Appendix A – Slope Stability and Erosion Areas
Tourtelot Annual Inspection Report
April 2010

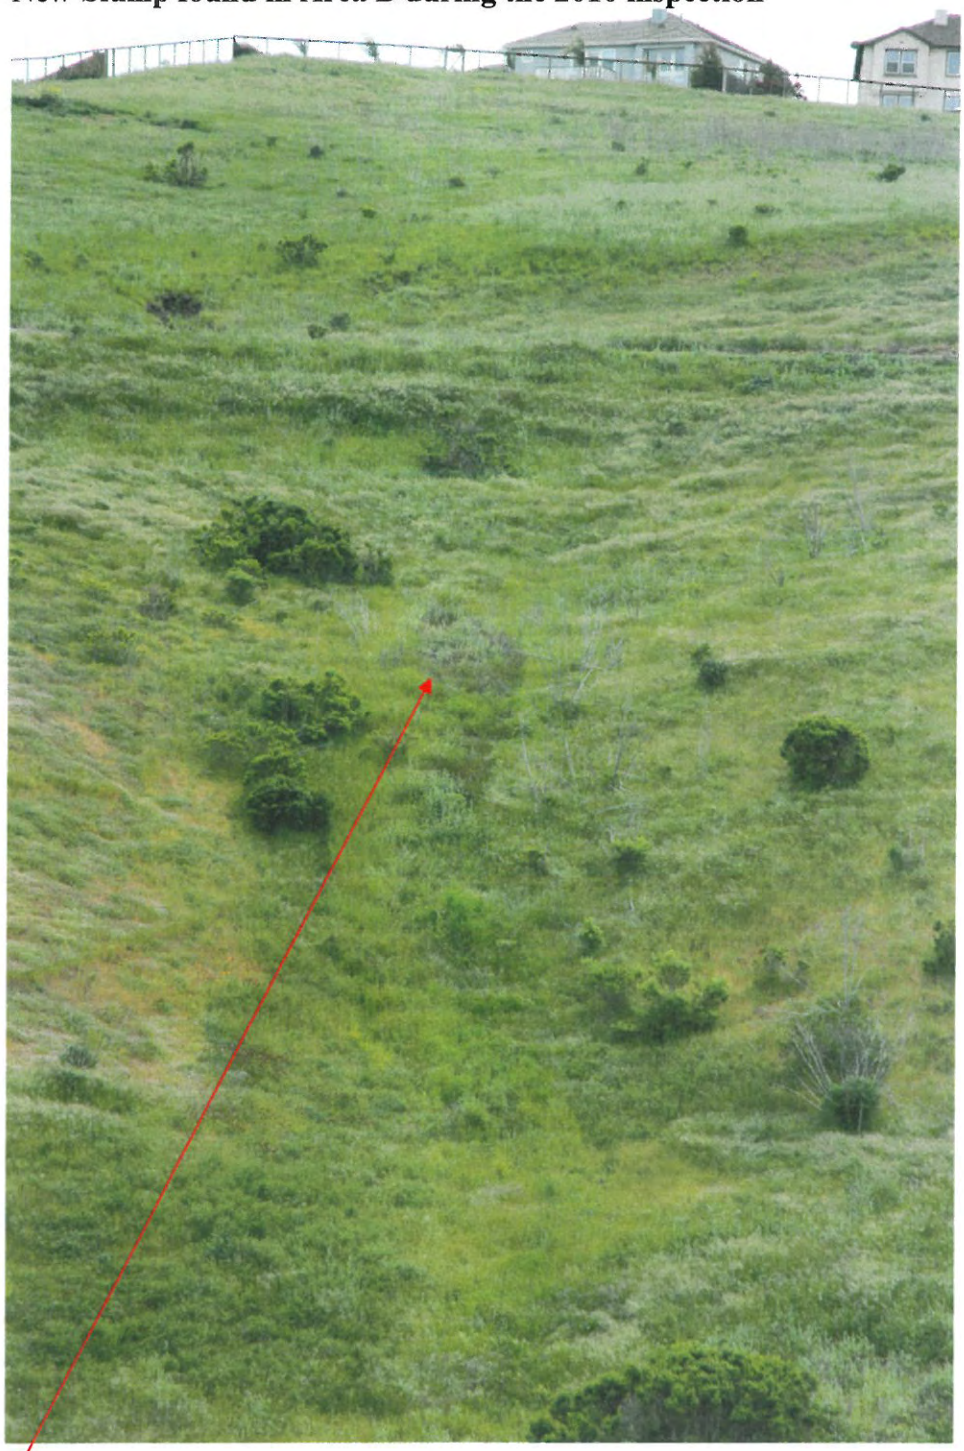
New Slump – See additional photos

New Slump found in Area B during the 2010 inspection

This slump measured 4' in width and 12' in total length. This is in a Historic Landslide Area. Monitoring will continue.
