# TOURTELOT CLEANUP PROJECT

## TOURTELOT PROJECT ANNUAL INSPECTION AND REPORT FORM

Benicia, California

**Appendix A – Slope Stability and Erosion Areas  
Tourtelot Annual Inspection Report  
May 2013**

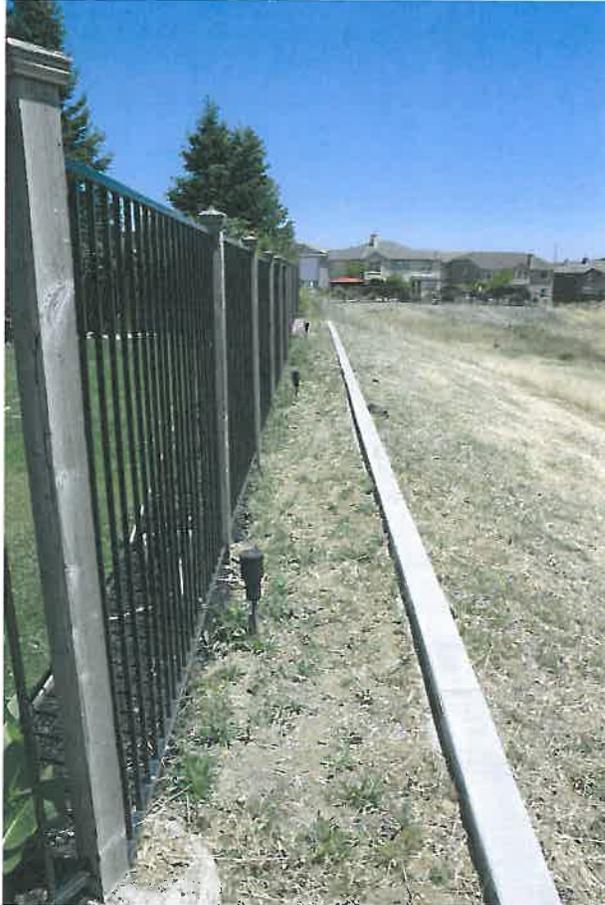
**2012**

This year's inspection along the properties abutting the "Open Space Restricted Area" indicates that all of the encroachments revealed during the 2012 inspection have been removed and no new encroachments were found. There are no encroachments existing that need to be addressed. The following were found during the 2012 field inspection in the Open Space.

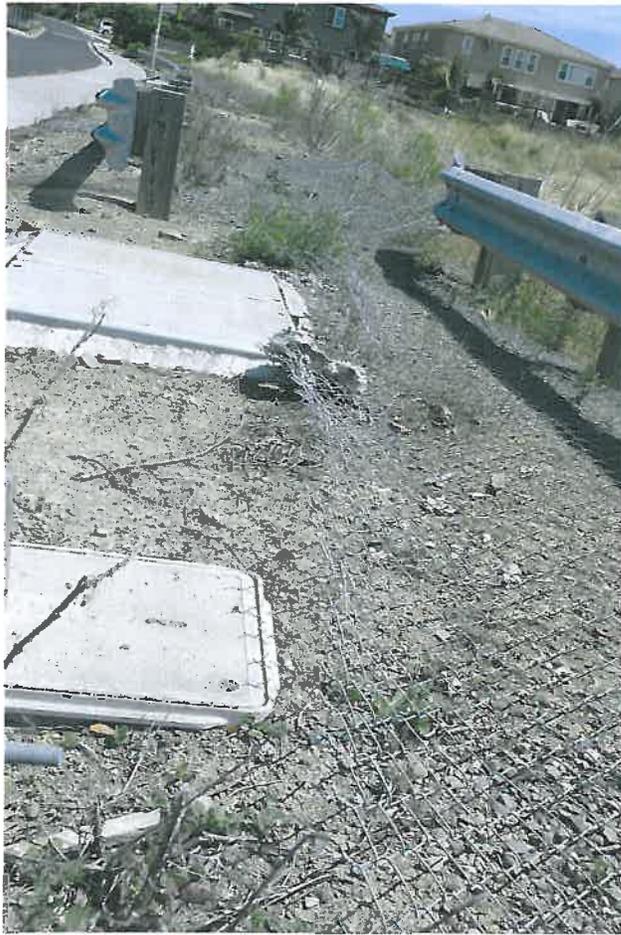
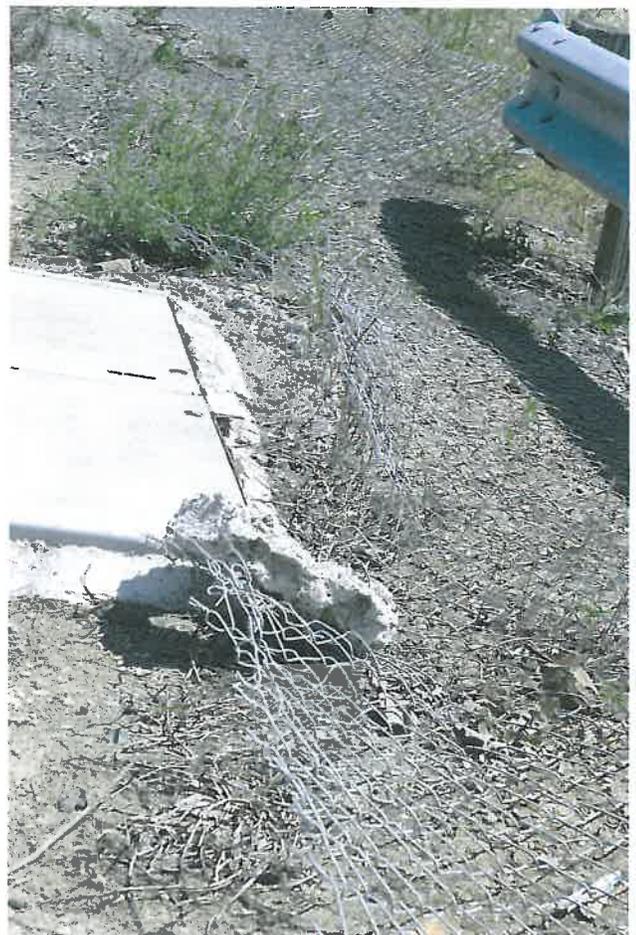
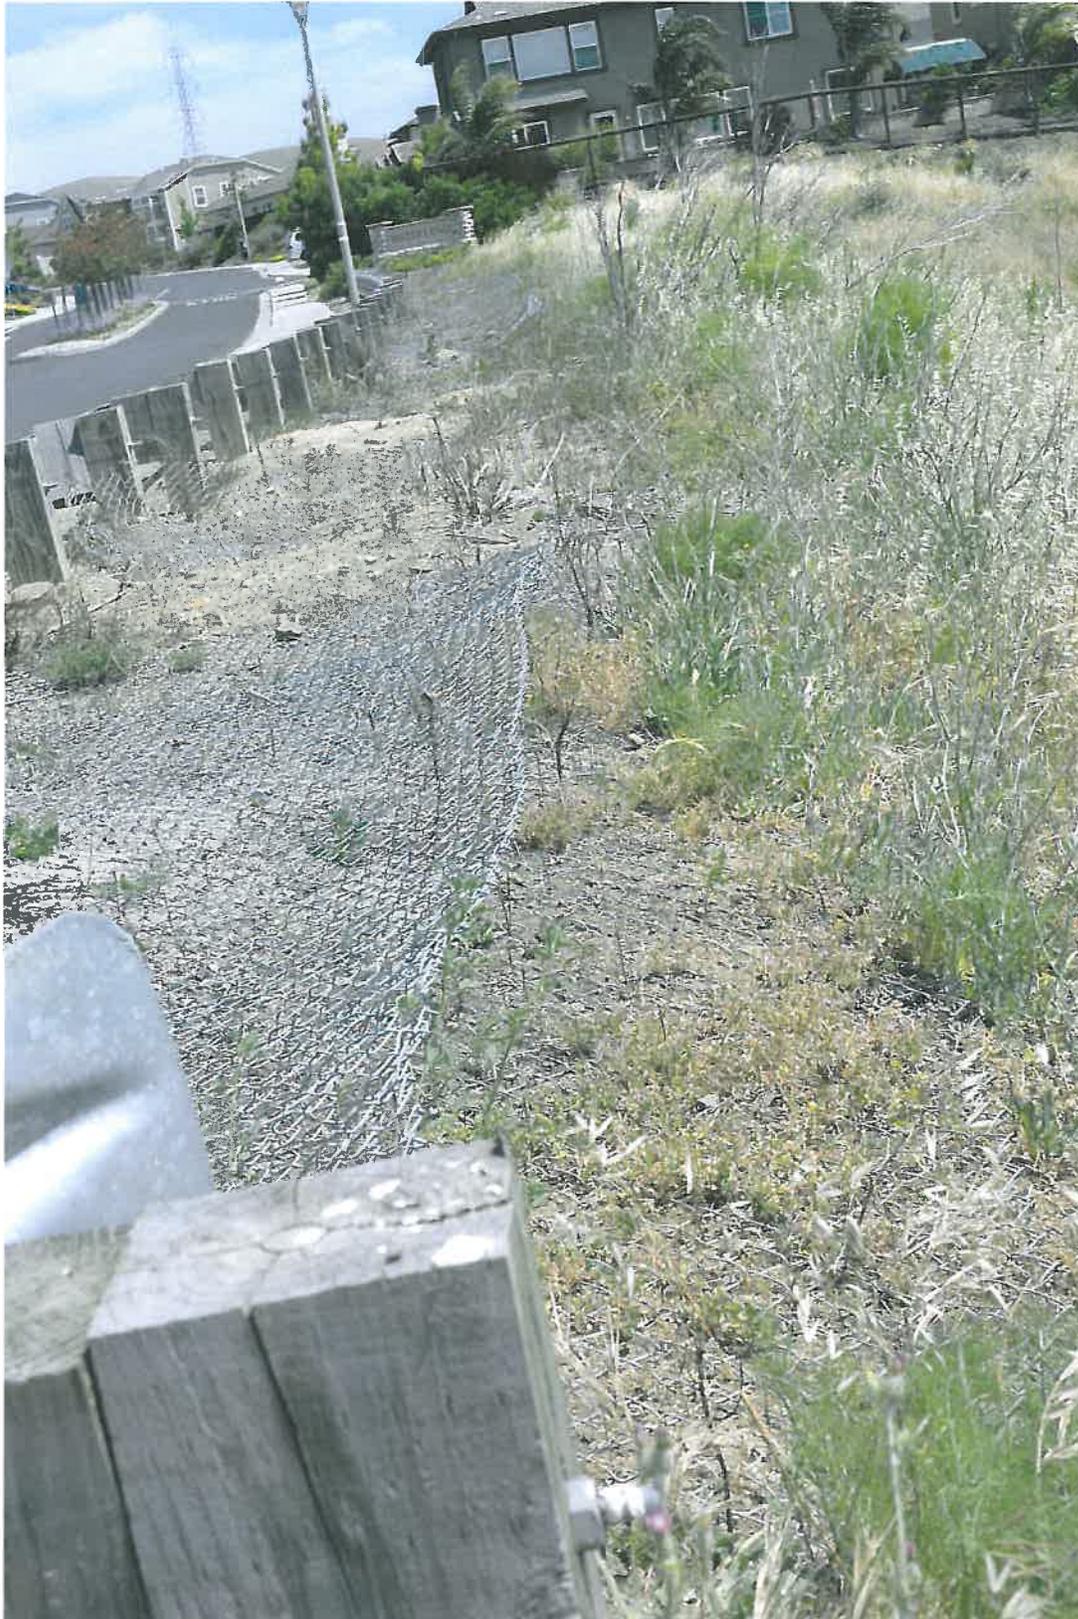
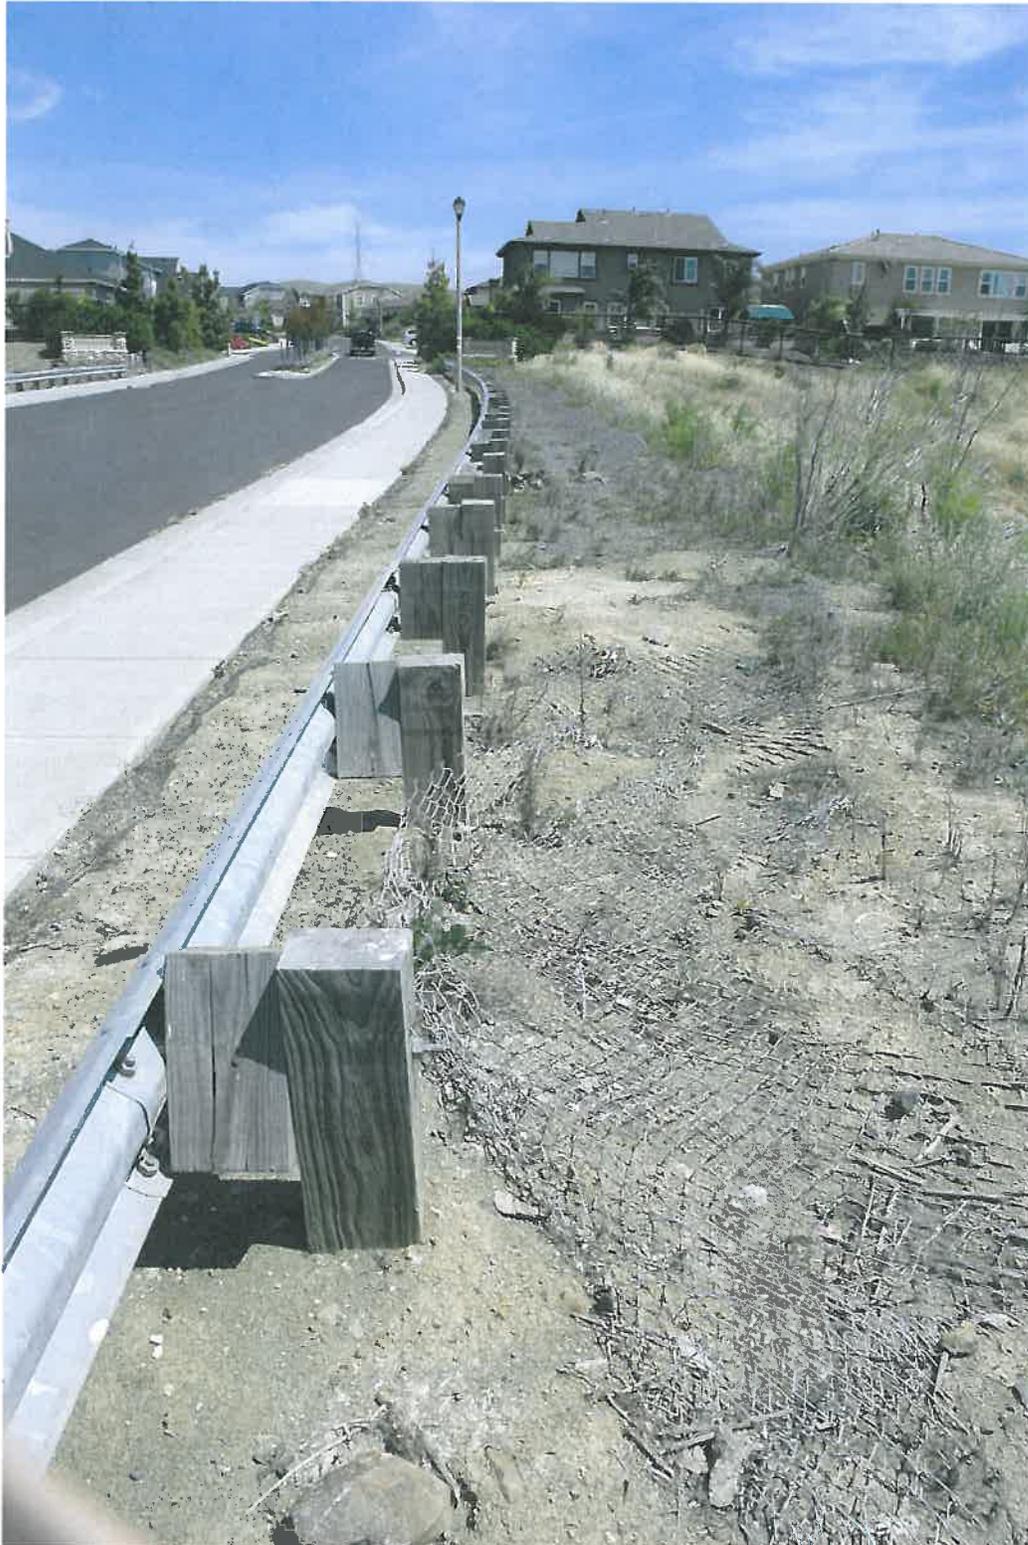
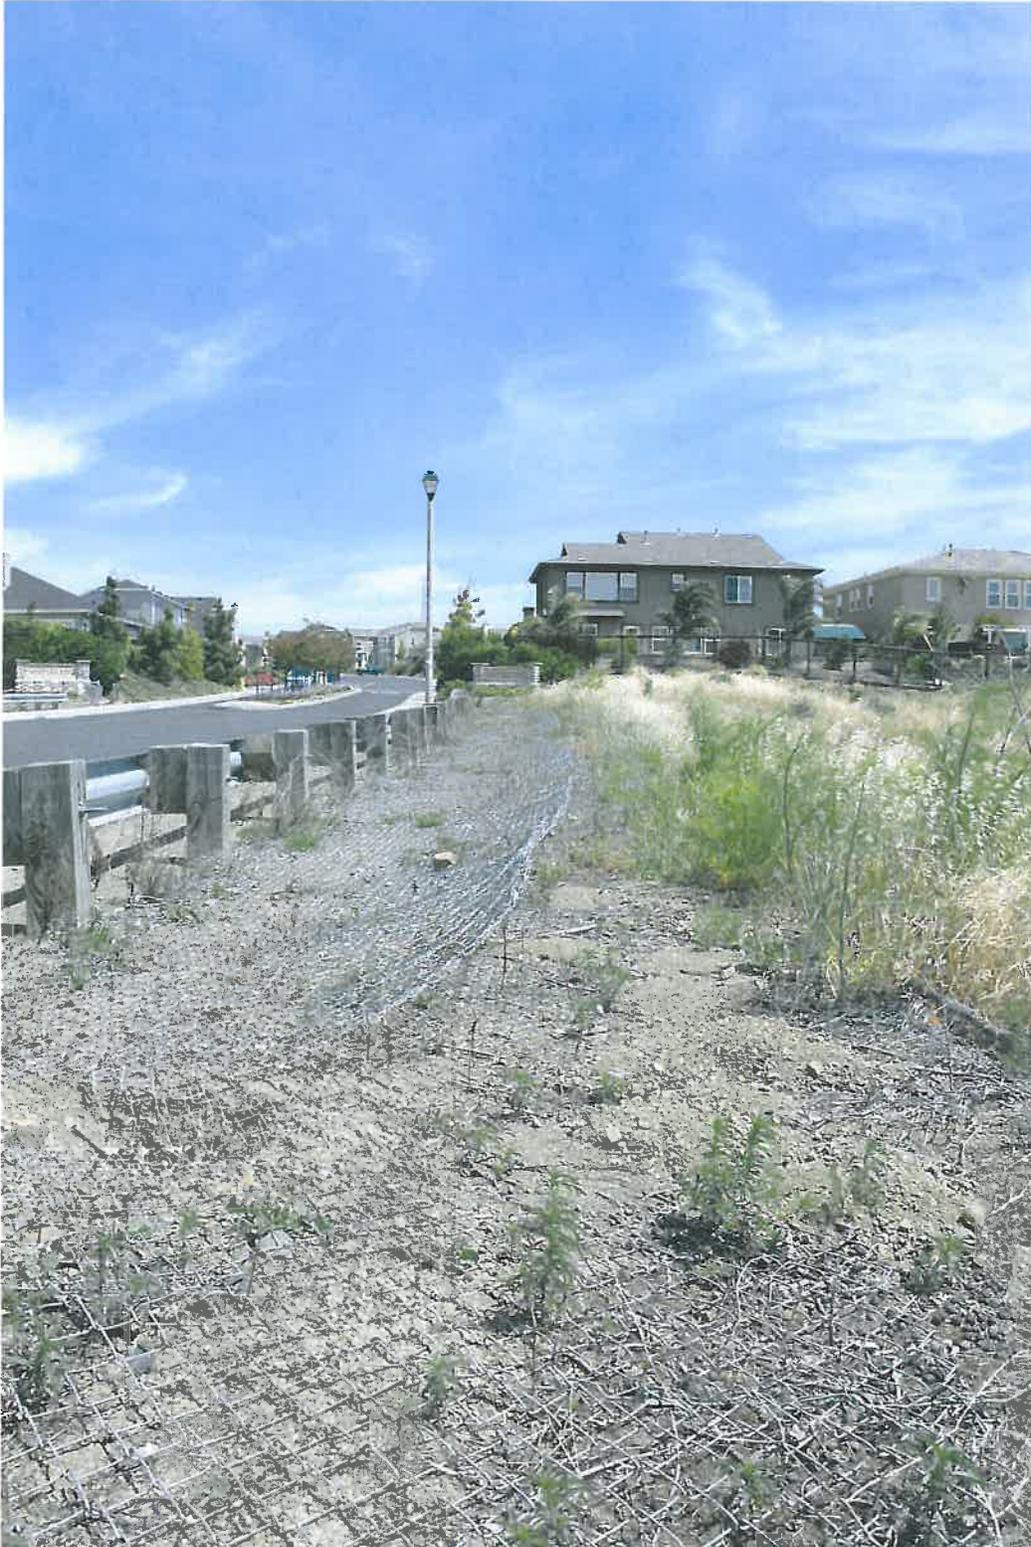
The Mesh Barrier is in the same condition as reported on in previous years. The Mesh Barrier has lifted along numerous edges at the top of slope on McAllister Drive. There are also areas on the slope that have lifted and need repair.

The barrier has been affected by the lifting of the pins that secure the barrier to the slope. The areas affected may need replacement because the mesh barrier is bent upwards.

The affected areas vary in size and shape. Some of the damage is along edges that run 2-3' in length. Other areas are sheets of mesh barrier approx. 5 foot square.

As mentioned above, the current conditions are similar to conditions found over the last six years. The photos included are representative of the lifting that has occurred along McAllister Drive. It is our recommendation that maintenance be performed in accordance with the O&M plan and the CAP (Contingency Action Plan) to re-pin the mesh barrier to the surface to prevent further “lifting” from the slope. The condition of the barrier on the western and eastern slopes is satisfactory and we do not recommend any maintenance in these areas. The ground cover is established and maintains the hold of the mesh barrier adequately on the slopes.

As noted in previous years, it is the recommendation of the consultant that repairs be made to the mesh barrier. The City has informed the consultant that repairs are being planned and the City is awaiting construction support.
