EXPANDED SITE INSPECTION REPORT

Environmental Investigation at the Formerly Used Defense Site (FUDS)
at the Benicia Arsenal, Benicia, California
FUDS Number: J09CA075600

FINAL

September 2005

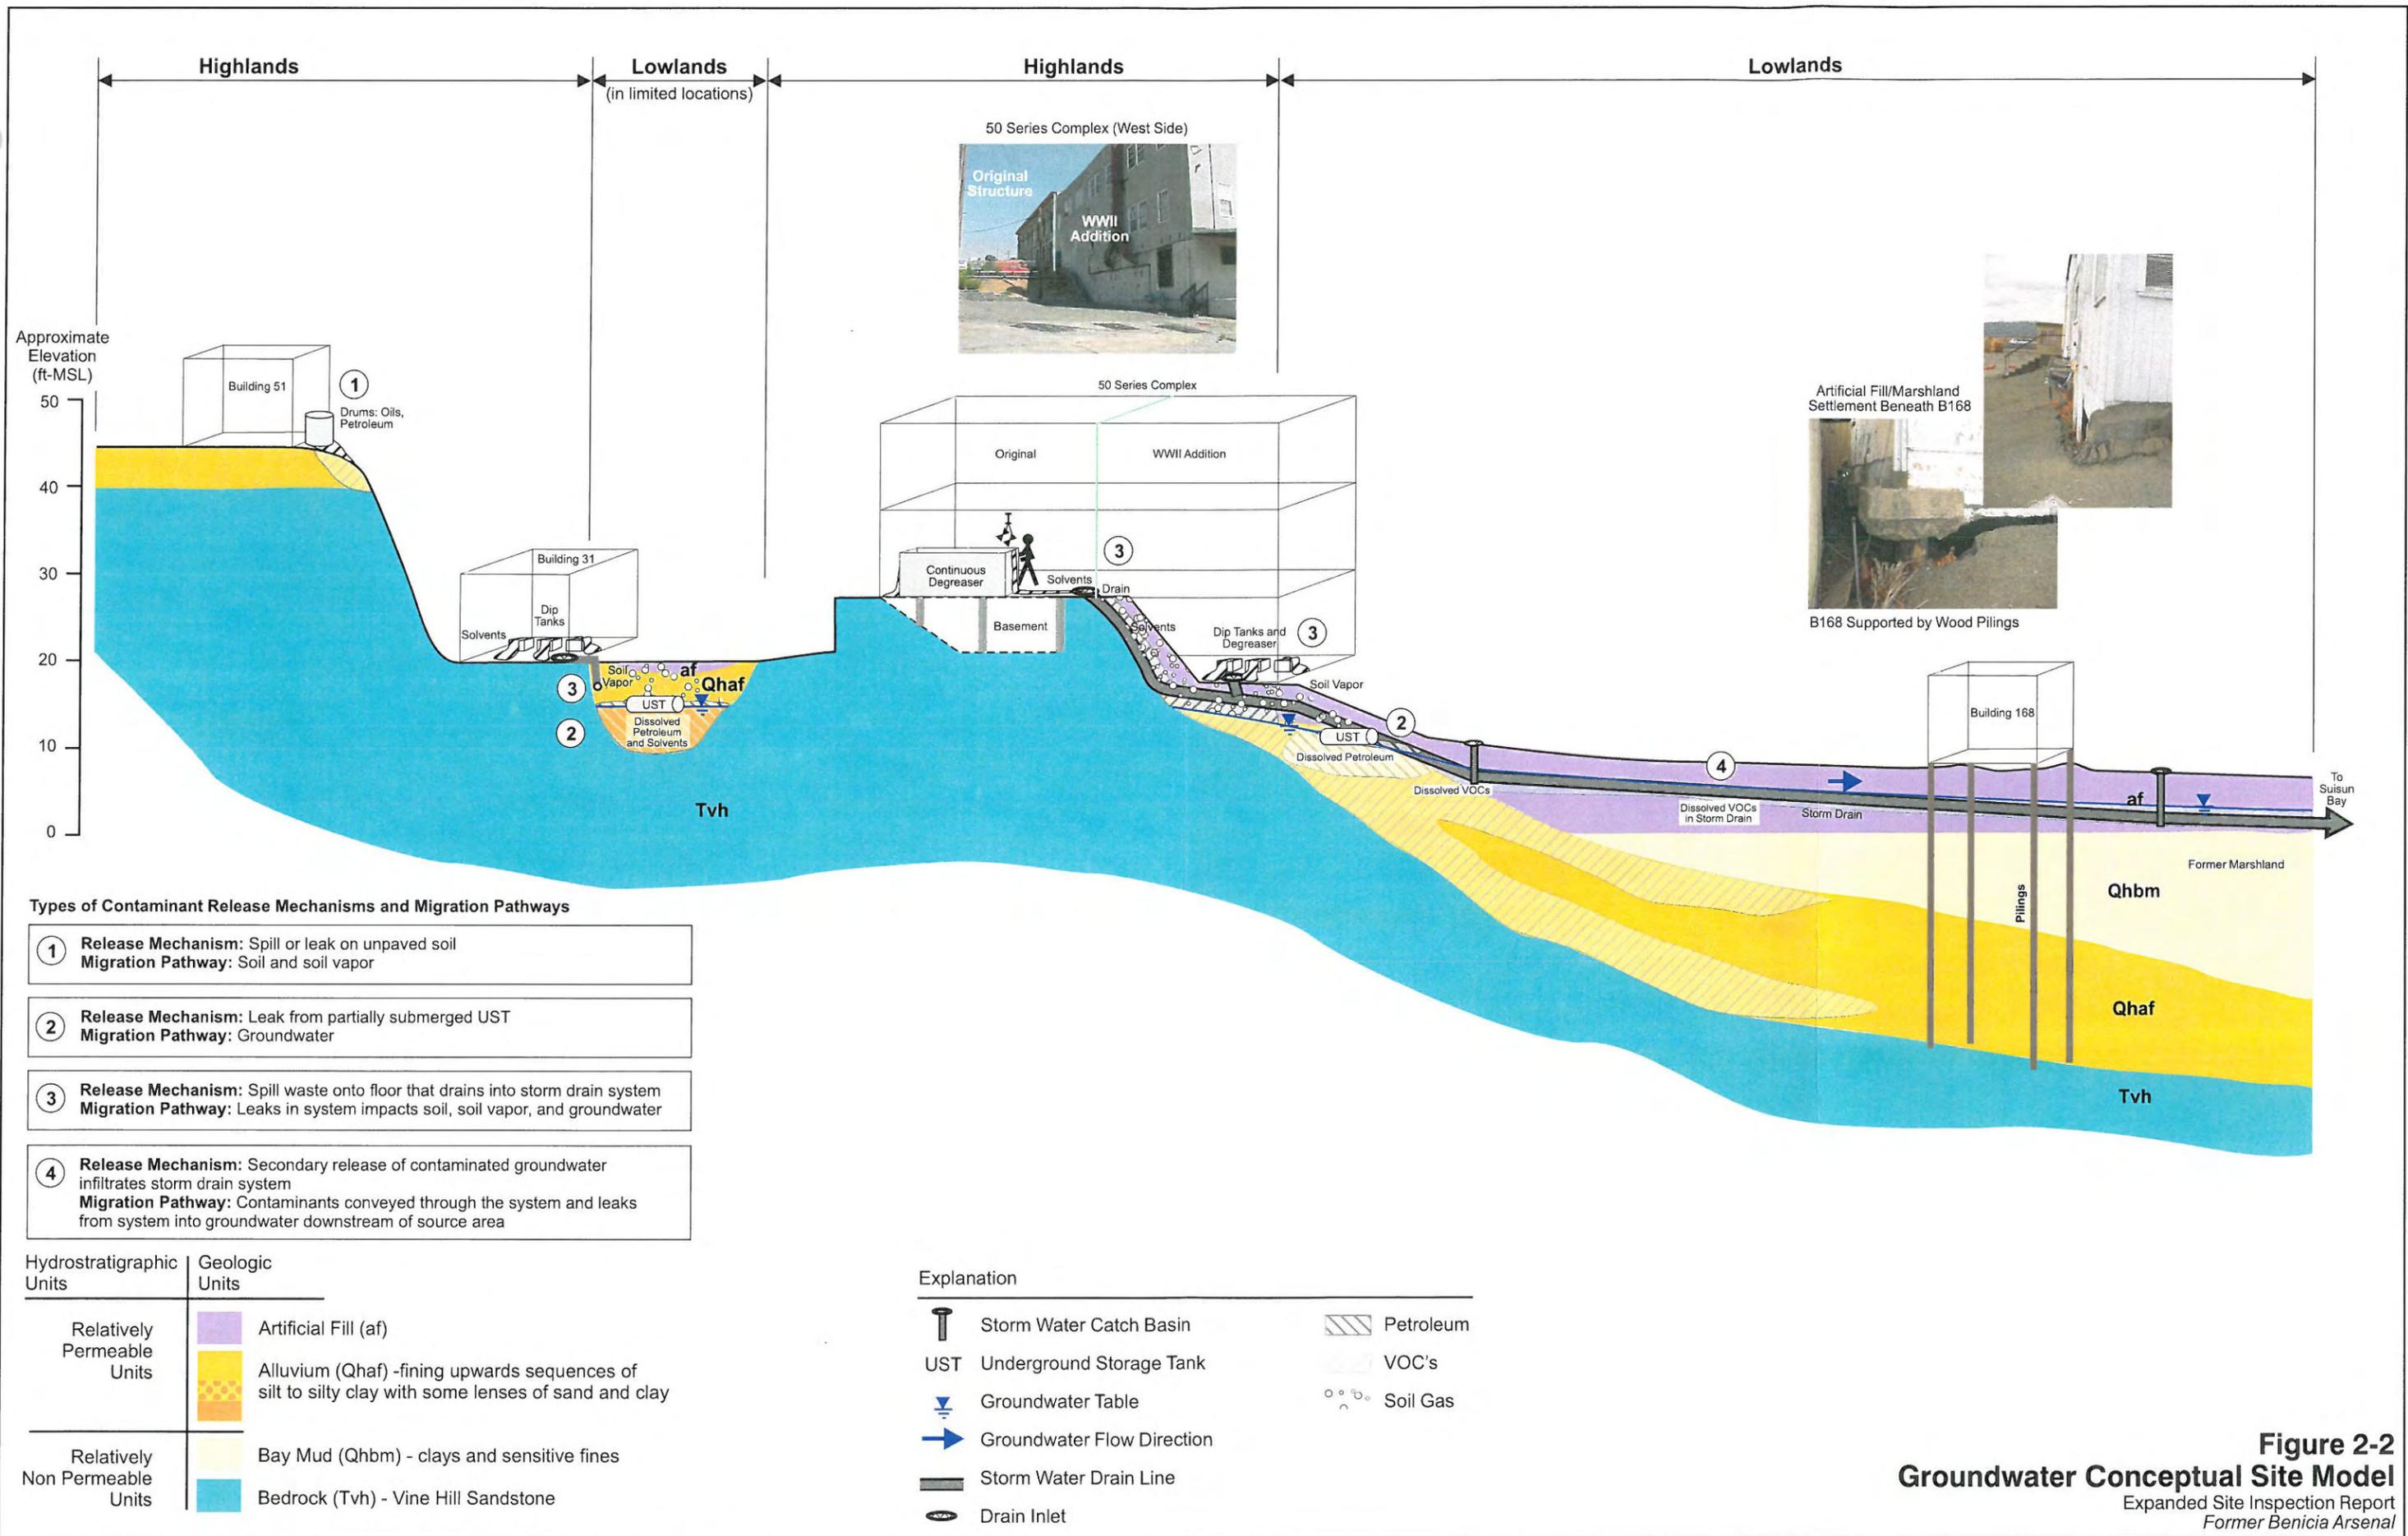
Figure 2-2
Groundwater Conceptual Site Model
 Expanded Site Inspection Report
 Former Benicia Arsenal

The site geology influences contaminant mobility. In the CSM, Figure 2-2, Pleistocene-age alluvial and fluvial deposits are shown overlying and inter-fingering the Bay Mud or lying directly on sandstone bedrock. The alluvial and fluvial deposits may be relatively permeable or nonpermeable depending on the ratio of gravel, silt, sand and clay. The Bay Mud and sandstone bedrock units are relatively nonpermeable.

Surface Water. Released chemicals may be transported by surface water either by dissolving or physically mixing with the fine sediment in surface water. Petroleum hydrocarbons could have dissolved and floated along surface water eventually deposited in the low-lying areas (Figure 2-2).

In the first hypothesis, low-density contaminants such as dissolved petroleum migrate along the top of the water table (Figure 2-2). In the second hypothesis, shown in Figure 2-2, dissolved VOCs could migrate preferentially in lenses of permeable alluvium that interfinger within the Bay Mud. The continuity of these lenses would likely dictate the extent of contaminates since the surrounding Bay Mud would prohibit migration due its very low permeability. The third hypothesis is that contaminants could migrate along the top of sandstone in weathered sandstone or overlying alluvium (Figure 2-2). The fourth hypothesis is an extension of the first and second hypotheses, such that the dissolved petroleum and VOCs in shallow groundwater intercept a more permeable path, like the storm water drain system and then are carried away from the source area.

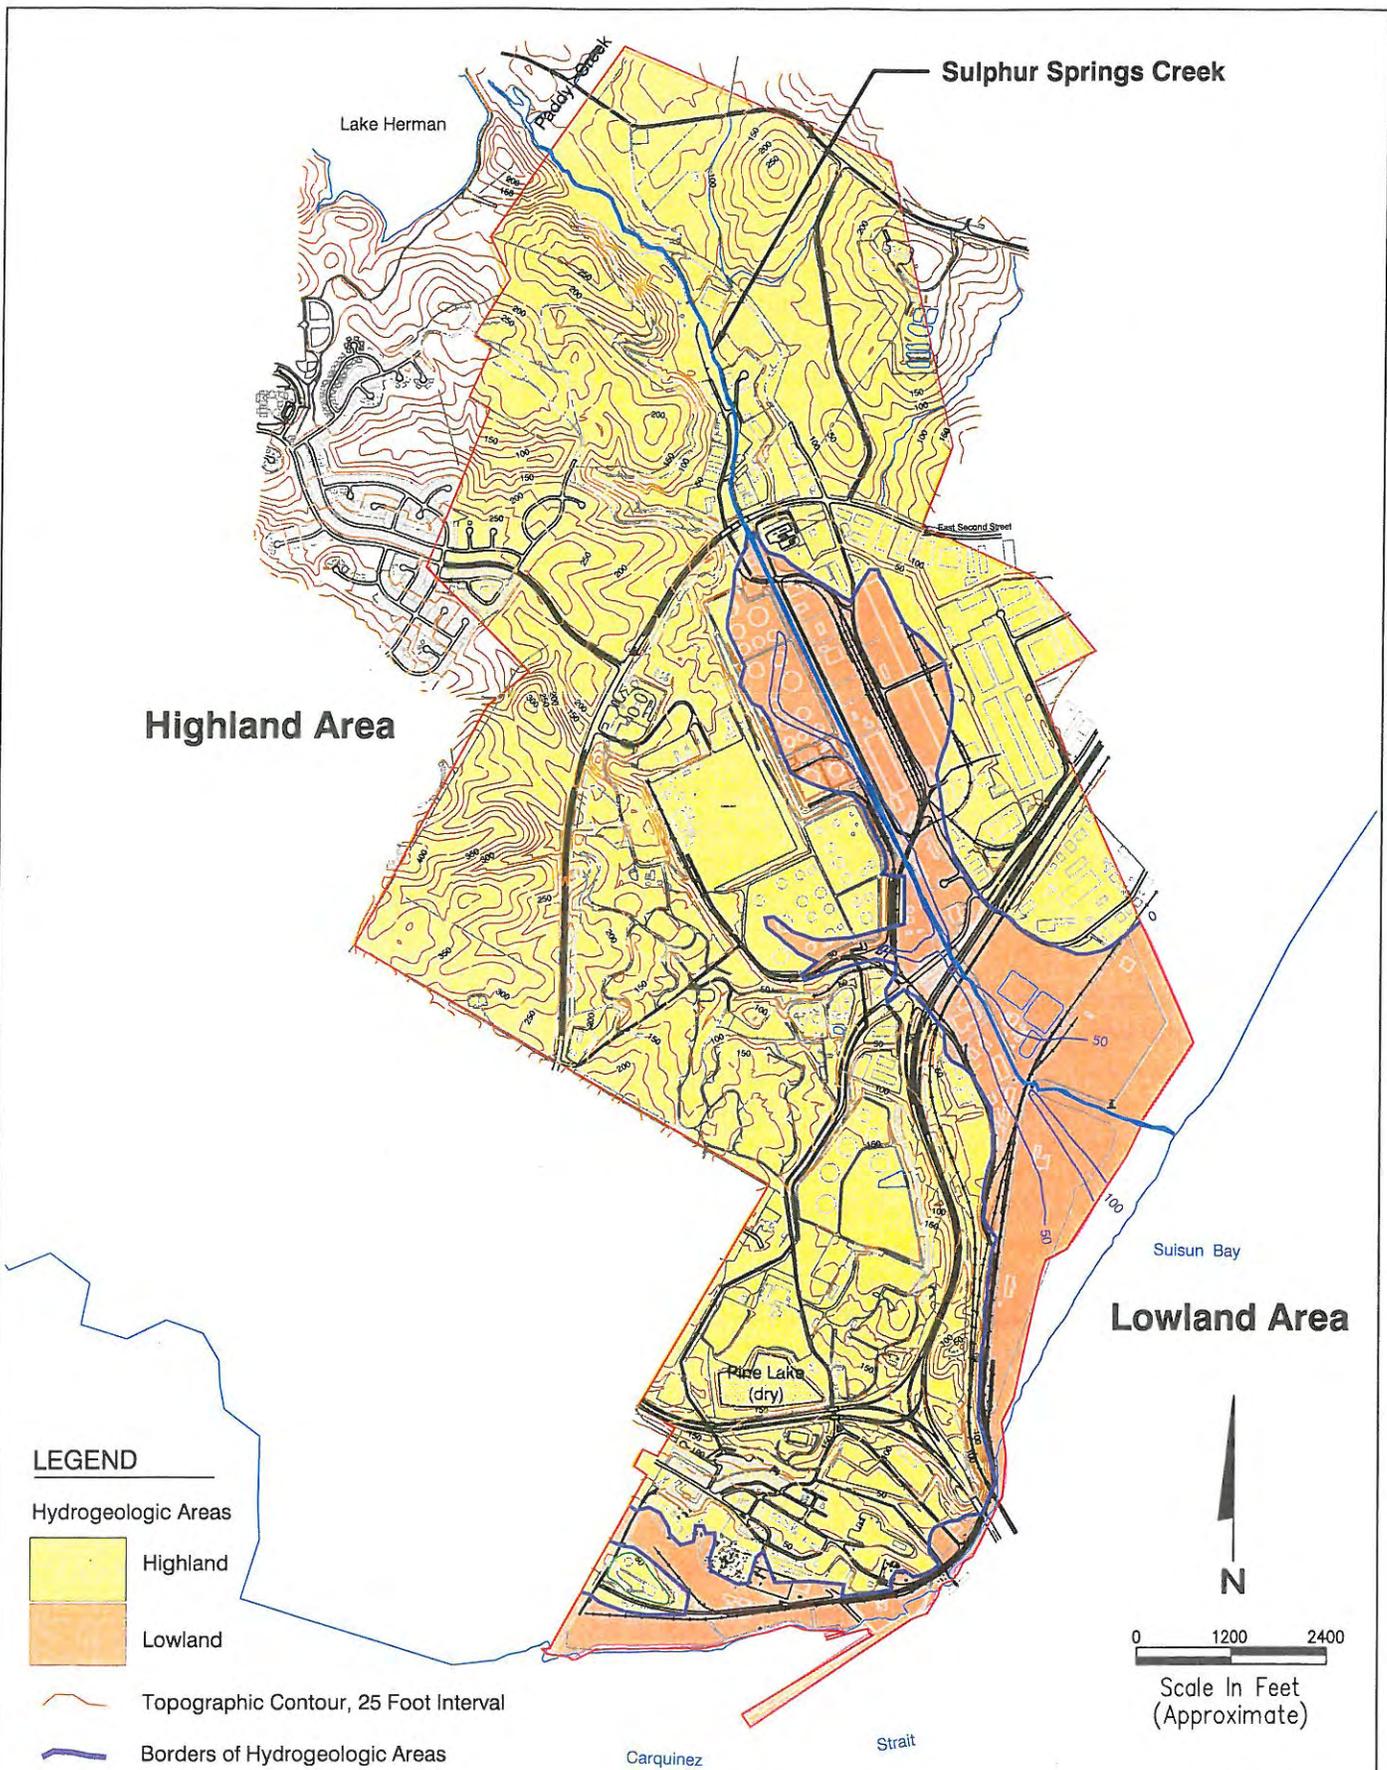
Figure 4-1
Hydrogeologic Areas
 Expanded Site Inspection Report
 Former Benicia Arsenal

The Lowland area, as shown on Figure 4-1 is the flatlands associated with the Sulphur Springs Creek drainage channel, and the former marshlands in the industrial area. The geology of the Lowland area is characterized by artificial fill and/or Holocene alluvial and fluvial deposits overlying the Bay Mud. The Bay Mud may lie directly on the bedrock, or older alluvial and fluvial deposits may be present on the bedrock surface below the Bay Mud.

In the industrial area, the boundary between the Lowlands and the Highlands is boundary of the former marshland (Figure 4-1). This boundary was changed slightly based on the CPT lithologic data. The previous boundary was based on photographs and a drawing of the former marshland and was fairly accurate. The CPT data changed the boundary slightly in the area of the Bottle Hill and the east side of the 50 Series Complex. At the eastern extent of the Bottle Hill, the edge of the former marshland is farther east and does not extend beneath the nearby buildings. On the east side of the 50 Series Complex, the former marshland swings around the complex toward the hillside to the north. This inland embayment matches a similar embayment on the east side of the 50 Series Complex. Essentially, the hill on which the 50 Series Complex sits, at one time, overlooked water on three sides.
