## SECTION 6 RESULTS AND ANALYSIS

## 6.1 Area R

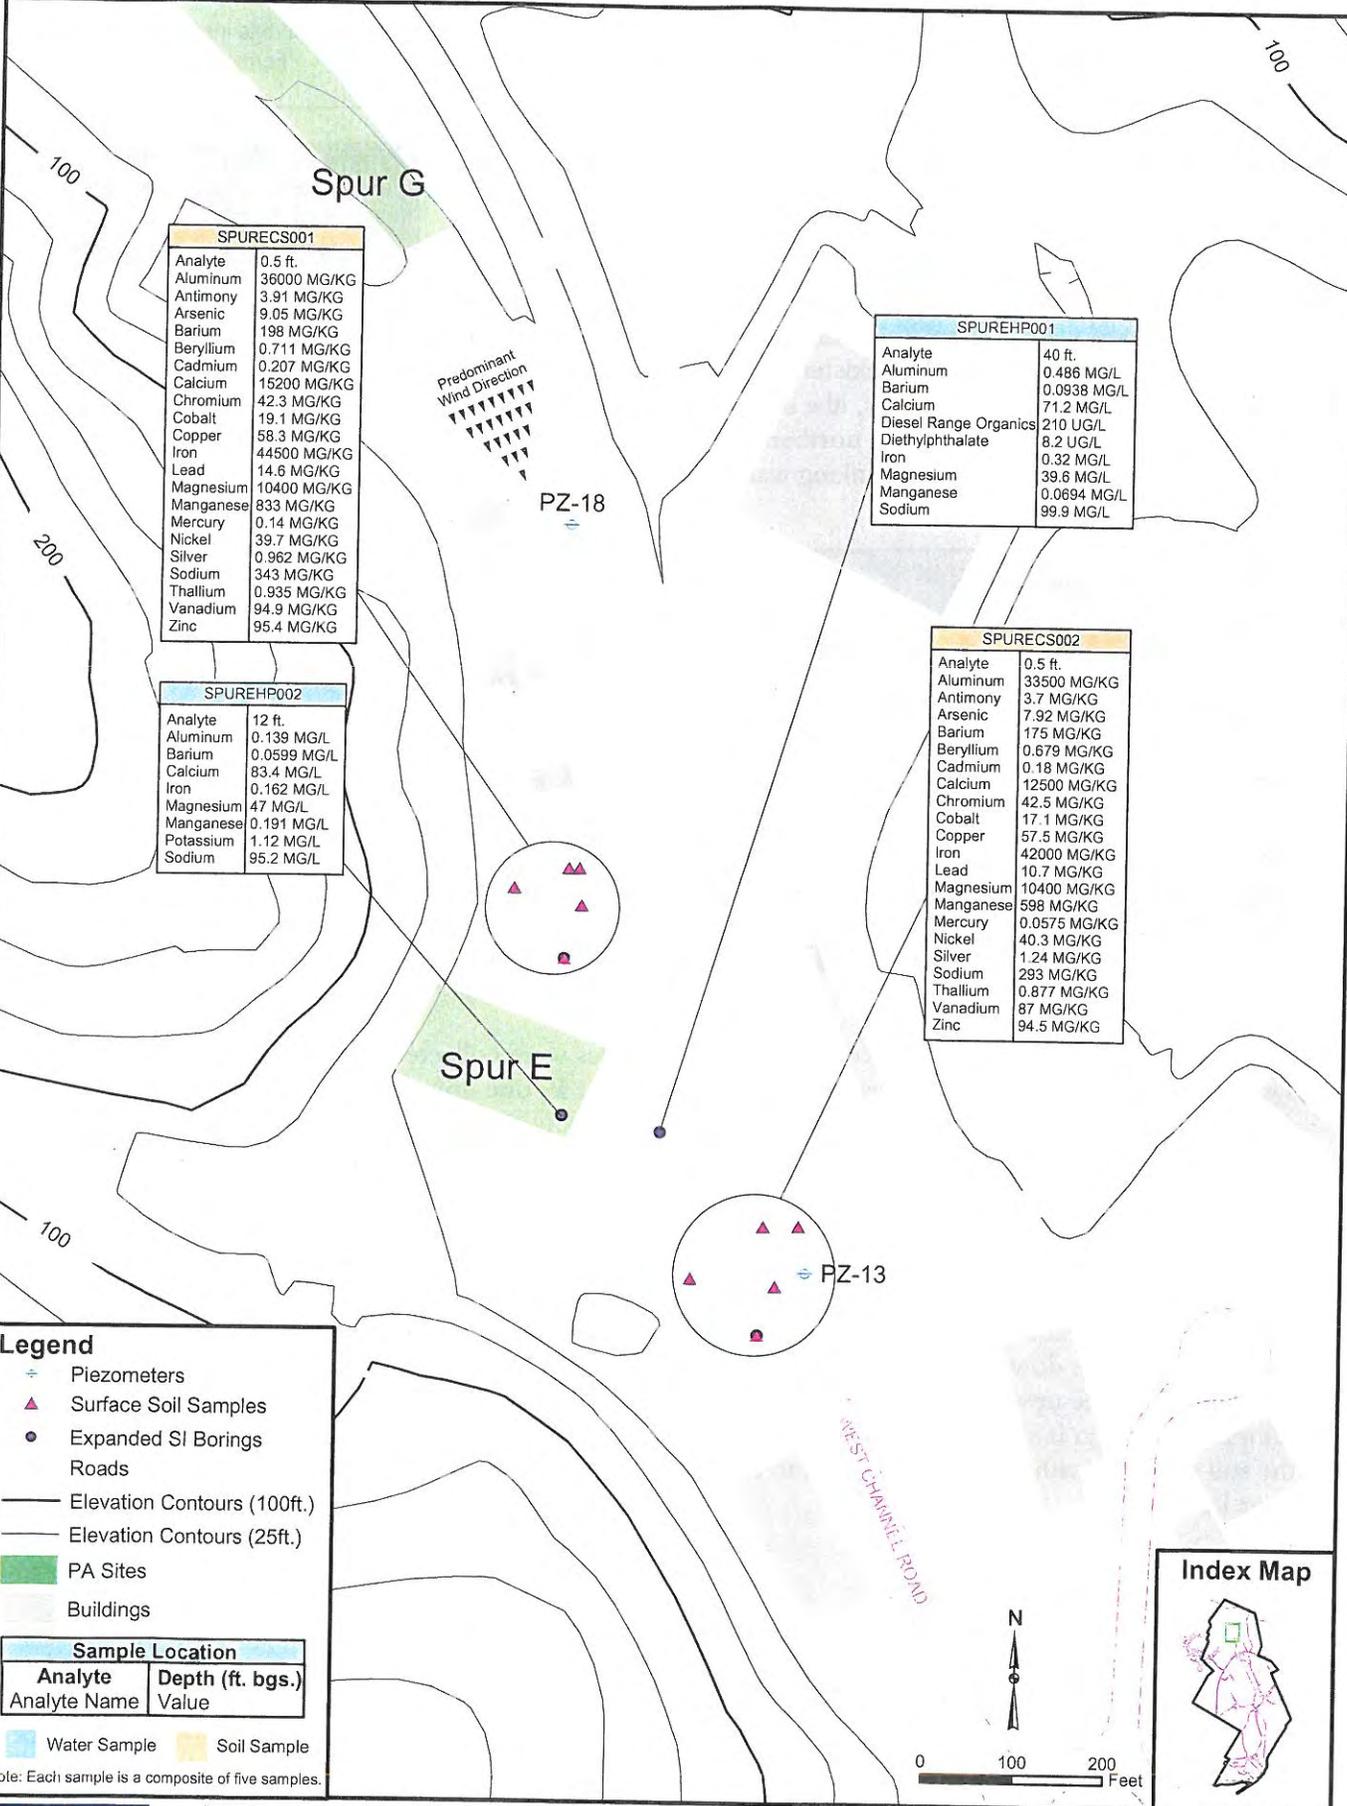
Two composite soil samples and two groundwater samples were collected for analysis at Spur E. Two 5-point composite soil samples were collected at Spur E, one upwind (SPURECS001) and one downwind (SPURECS002) of the former burn cage below any aggregate or paving materials to determine the presence or absence of metals and explosives from former burning of ammunition in a burn cage. The downwind sample was to provide information on impacts to surface soil from particulates produced during burning, which were blown, downwind of the former burn cage. The upwind sample results were used to determine ambient concentrations in the area. Table 6-1 shows the results, the percentage difference between the upwind or ambient background sample and the downwind sample and the BSL for each metal reported. The percent difference column shows a "+" sign when the downwind sample was detected at a higher concentration than the upwind sample. When the upwind soil sample was detected at a higher concentration than the downwind sample, a "-" sign is shown in the percent difference column. Figure 6-2 illustrates the location of the soil samples (with results) in relation to the approximately location of the former burn cage at Spur E.

Metal concentrations from the upwind sample were up to 59 percent greater in concentration than the downwind sample, except for chromium, nickel, and silver. Metals that are typically associated with ammunition are antimony, arsenic, copper, lead, and zinc (Interstate Technology and Regulatory Council, 2003). These metals were found in greater concentrations in the upwind sample than the downwind sample and all of these results are below BSLs and below ambient concentrations except copper. Copper was identified above ambient concentrations in the upwind and the downwind soil sample. Even though copper was found above ambient concentrations, the evidence of the other ammunition-related metals concentrations that were below ambient concentrations or BSLs, especially in the downwind sample, indicates that there is no significant impact from the former burning of ammunition in the burn cage at Spur E.

No further DoD action is indicated at the former burn cage at Spur E for the following reasons:

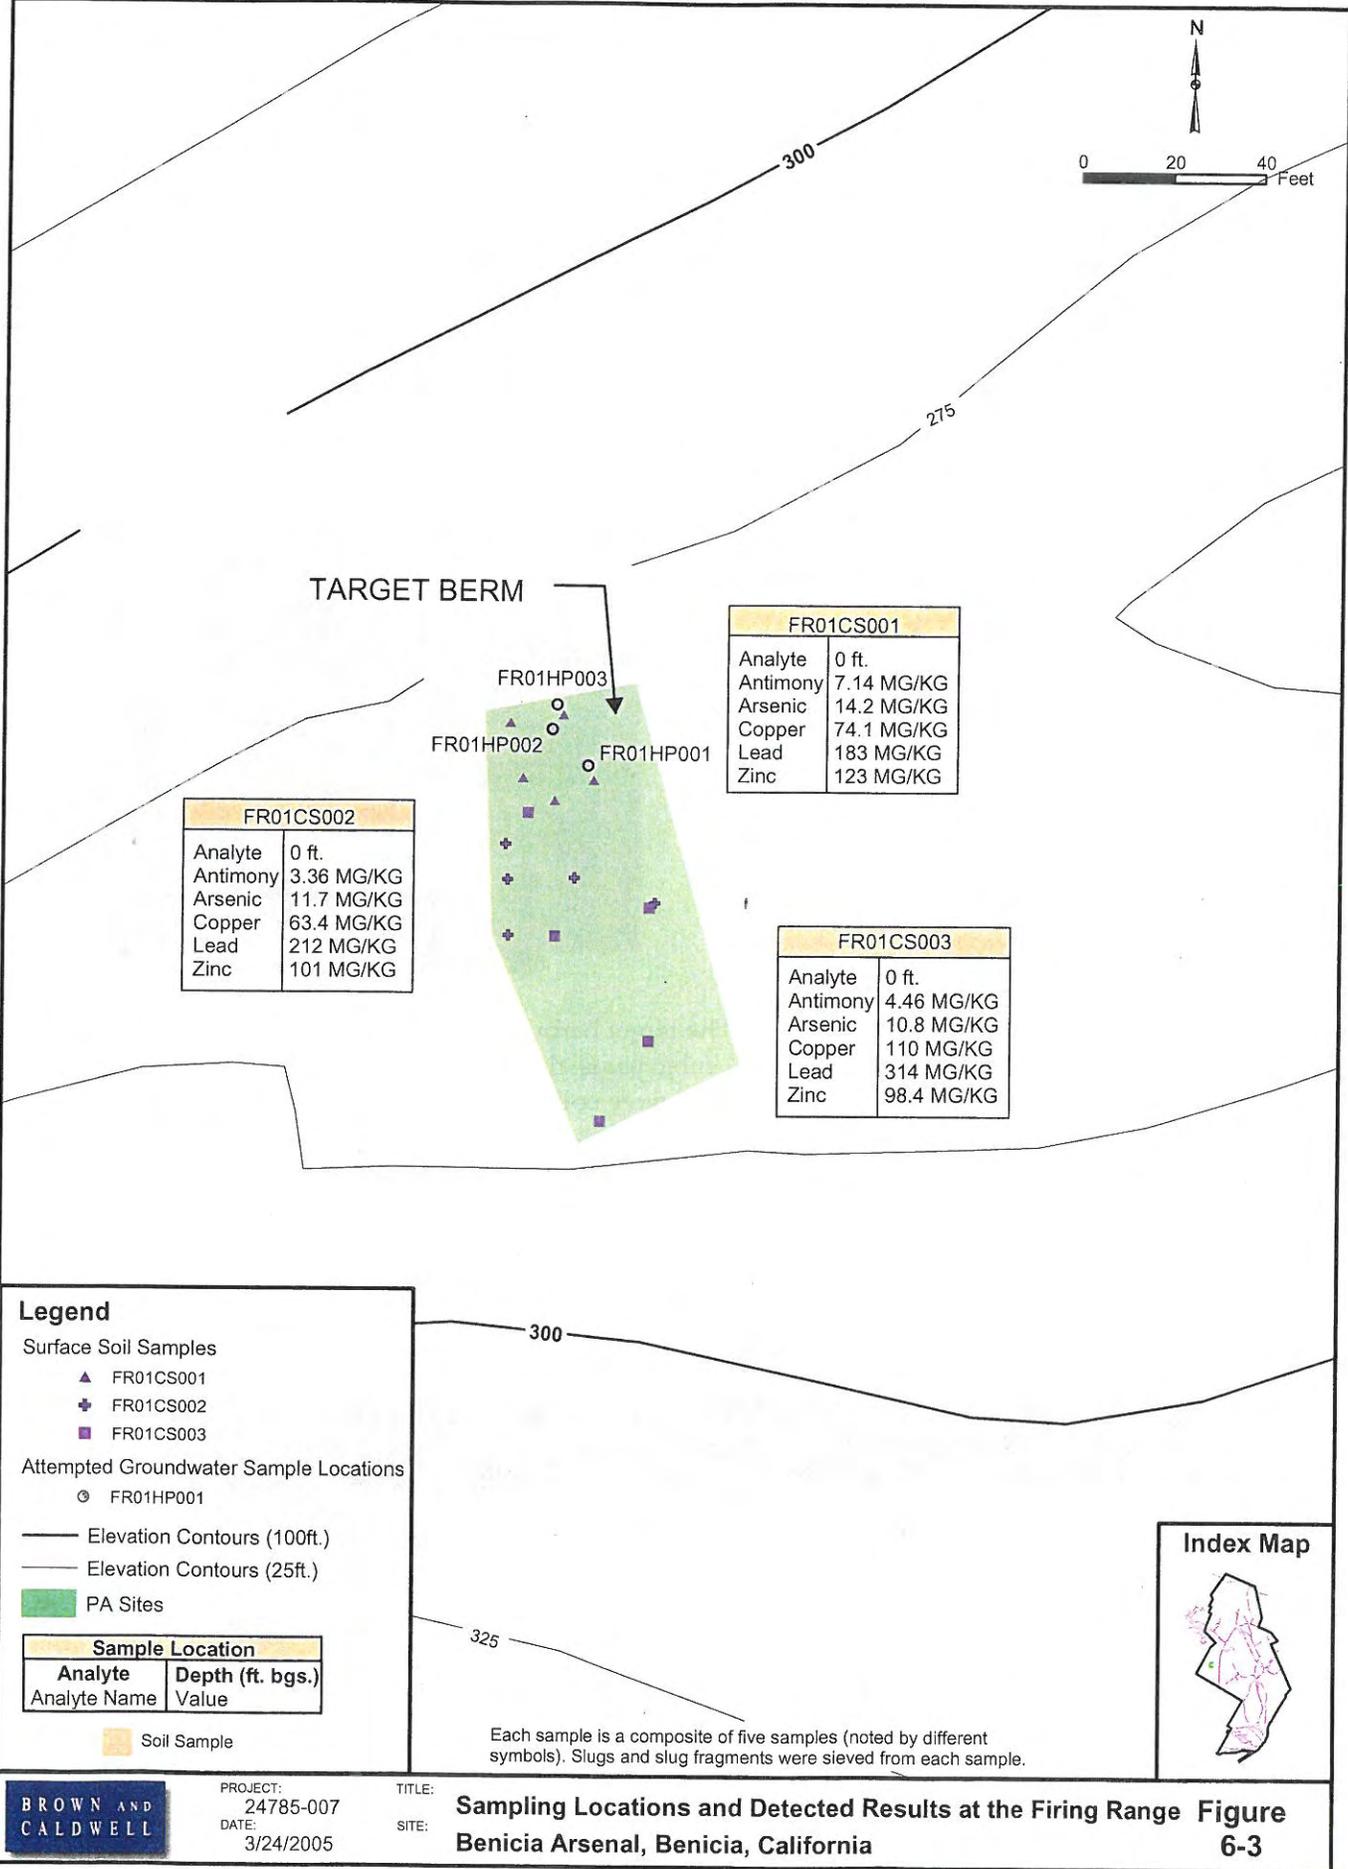
TARGET BERM

All the sample results for the individual metals were below BSLs (Table 6-3).

Each sample is a composite of five samples (noted by different symbols). Slugs and slug fragments were sieved from each sample.

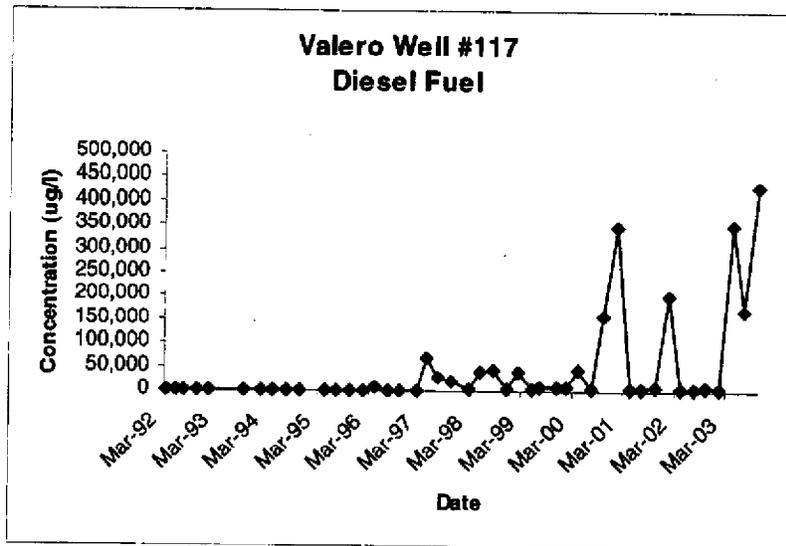
Diesel fuel concentrations in Valero Well #117 have steadily increased as shown on the following graph. In 2003, toluene, gasoline, diesel fuel, and motor oil have been reported in this well at concentrations that exceed their respective ESLs (Table 6-5). According to the Valero Refinery, a detailed evaluation was performed in 1999-2000 that showed the contaminants detected in Valero Well 117 are not related to Valero activities and do not originate from the Valero Refinery property

(URS, 2003). The source of the hydrocarbons is not known but appears to be related to a recent release or discharge in the area.

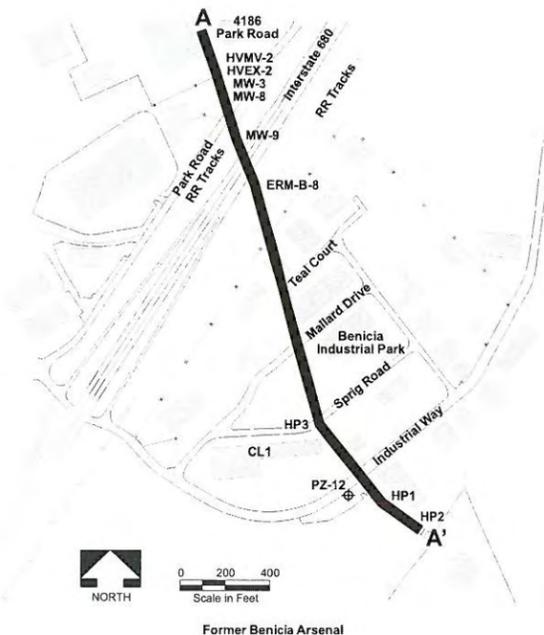
**Figure 6-5**  
**Geologic Cross Section A-A'**  
**from 4186 Park Road to**  
**Former Nike Assembly Facility**  
 Expanded Site Inspection Report  
 Former Benicia Arsenal

Concentrations of TCE, cis-1,2 DCE, and vinyl chloride exceed MCLs in the boring locations downgradient of CL1 and at the eastern Waste Area. TCE was detected in an upgradient boring (WA01HP003), which suggests there may be another source of contamination other than from former DoD activities. RWQCB files provided information on a current RWQCB site nearby, upgradient to CL 1, the Open Ditch and the Waste Areas, 4186 Park Road, as shown on Figure 6-5. This figure illustrates the lithology of the area and TCE concentrations in groundwater from 4186 Park Road to the former NIKE missile Assembly facility (CL1). Reportedly, solvent waste was dumped directly on the ground surface and a sump within the building leaked at 4186 Park Road. TCE has impacted groundwater up to 34,000 µg/L (based on February 2004 sampling). Bedrock at 4186 Park Road is shale with reportedly 10 to 20 feet of the shale weathered. Older reports indicate that the bedrock is sandstone. The geologic unit for this area is the Great Valley sequence, which is characterized by interbedded sandstone and shale.

The conceptual site model for this area is very similar to the industrial area where the highlands, with an absence of water at shallow bedrock, meet the lowlands where water is within alluvial sediments. The primary difference between the models is that the Bay Mud (marshland) is farther away (0.25 mile) from the highlands and the alluvium in this area is much thicker (10-15 feet in the industrial area compared to 75 feet at WA01HP001). At 4186 Park Road, solvents are within the weathered portion of the shale and exiting into the alluvium likely at the contact between the alluvium and the shale at a point between MW-8 and MW-9 (Figure 6-5). At ERM-B-8, TCE was not reported in groundwater (Figure 6-5). Based on the stratigraphy, the higher TCE concentrations are likely to be found at contact between the alluvium/shale, which is approximately 15 feet below the total depth of the boring. It is plausible that the solvent-impacted groundwater from 4186 Park Road has traveled past ERM-B-8.

Once access to Septic Tank 194 and CL2 is granted, a geophysical investigation is recommended at CL 2 to determine if a UST is present and an investigation at Septic Tank 194 is recommended to determine if discharge from CL 1 has impacted groundwater. No further action by USACE can be done until access is provided. No further DoD action is indicated for the Open Ditch and Western Waste due to MtBE and the recent diesel fuel and motor oil concentrations reported in Valero Well #117.

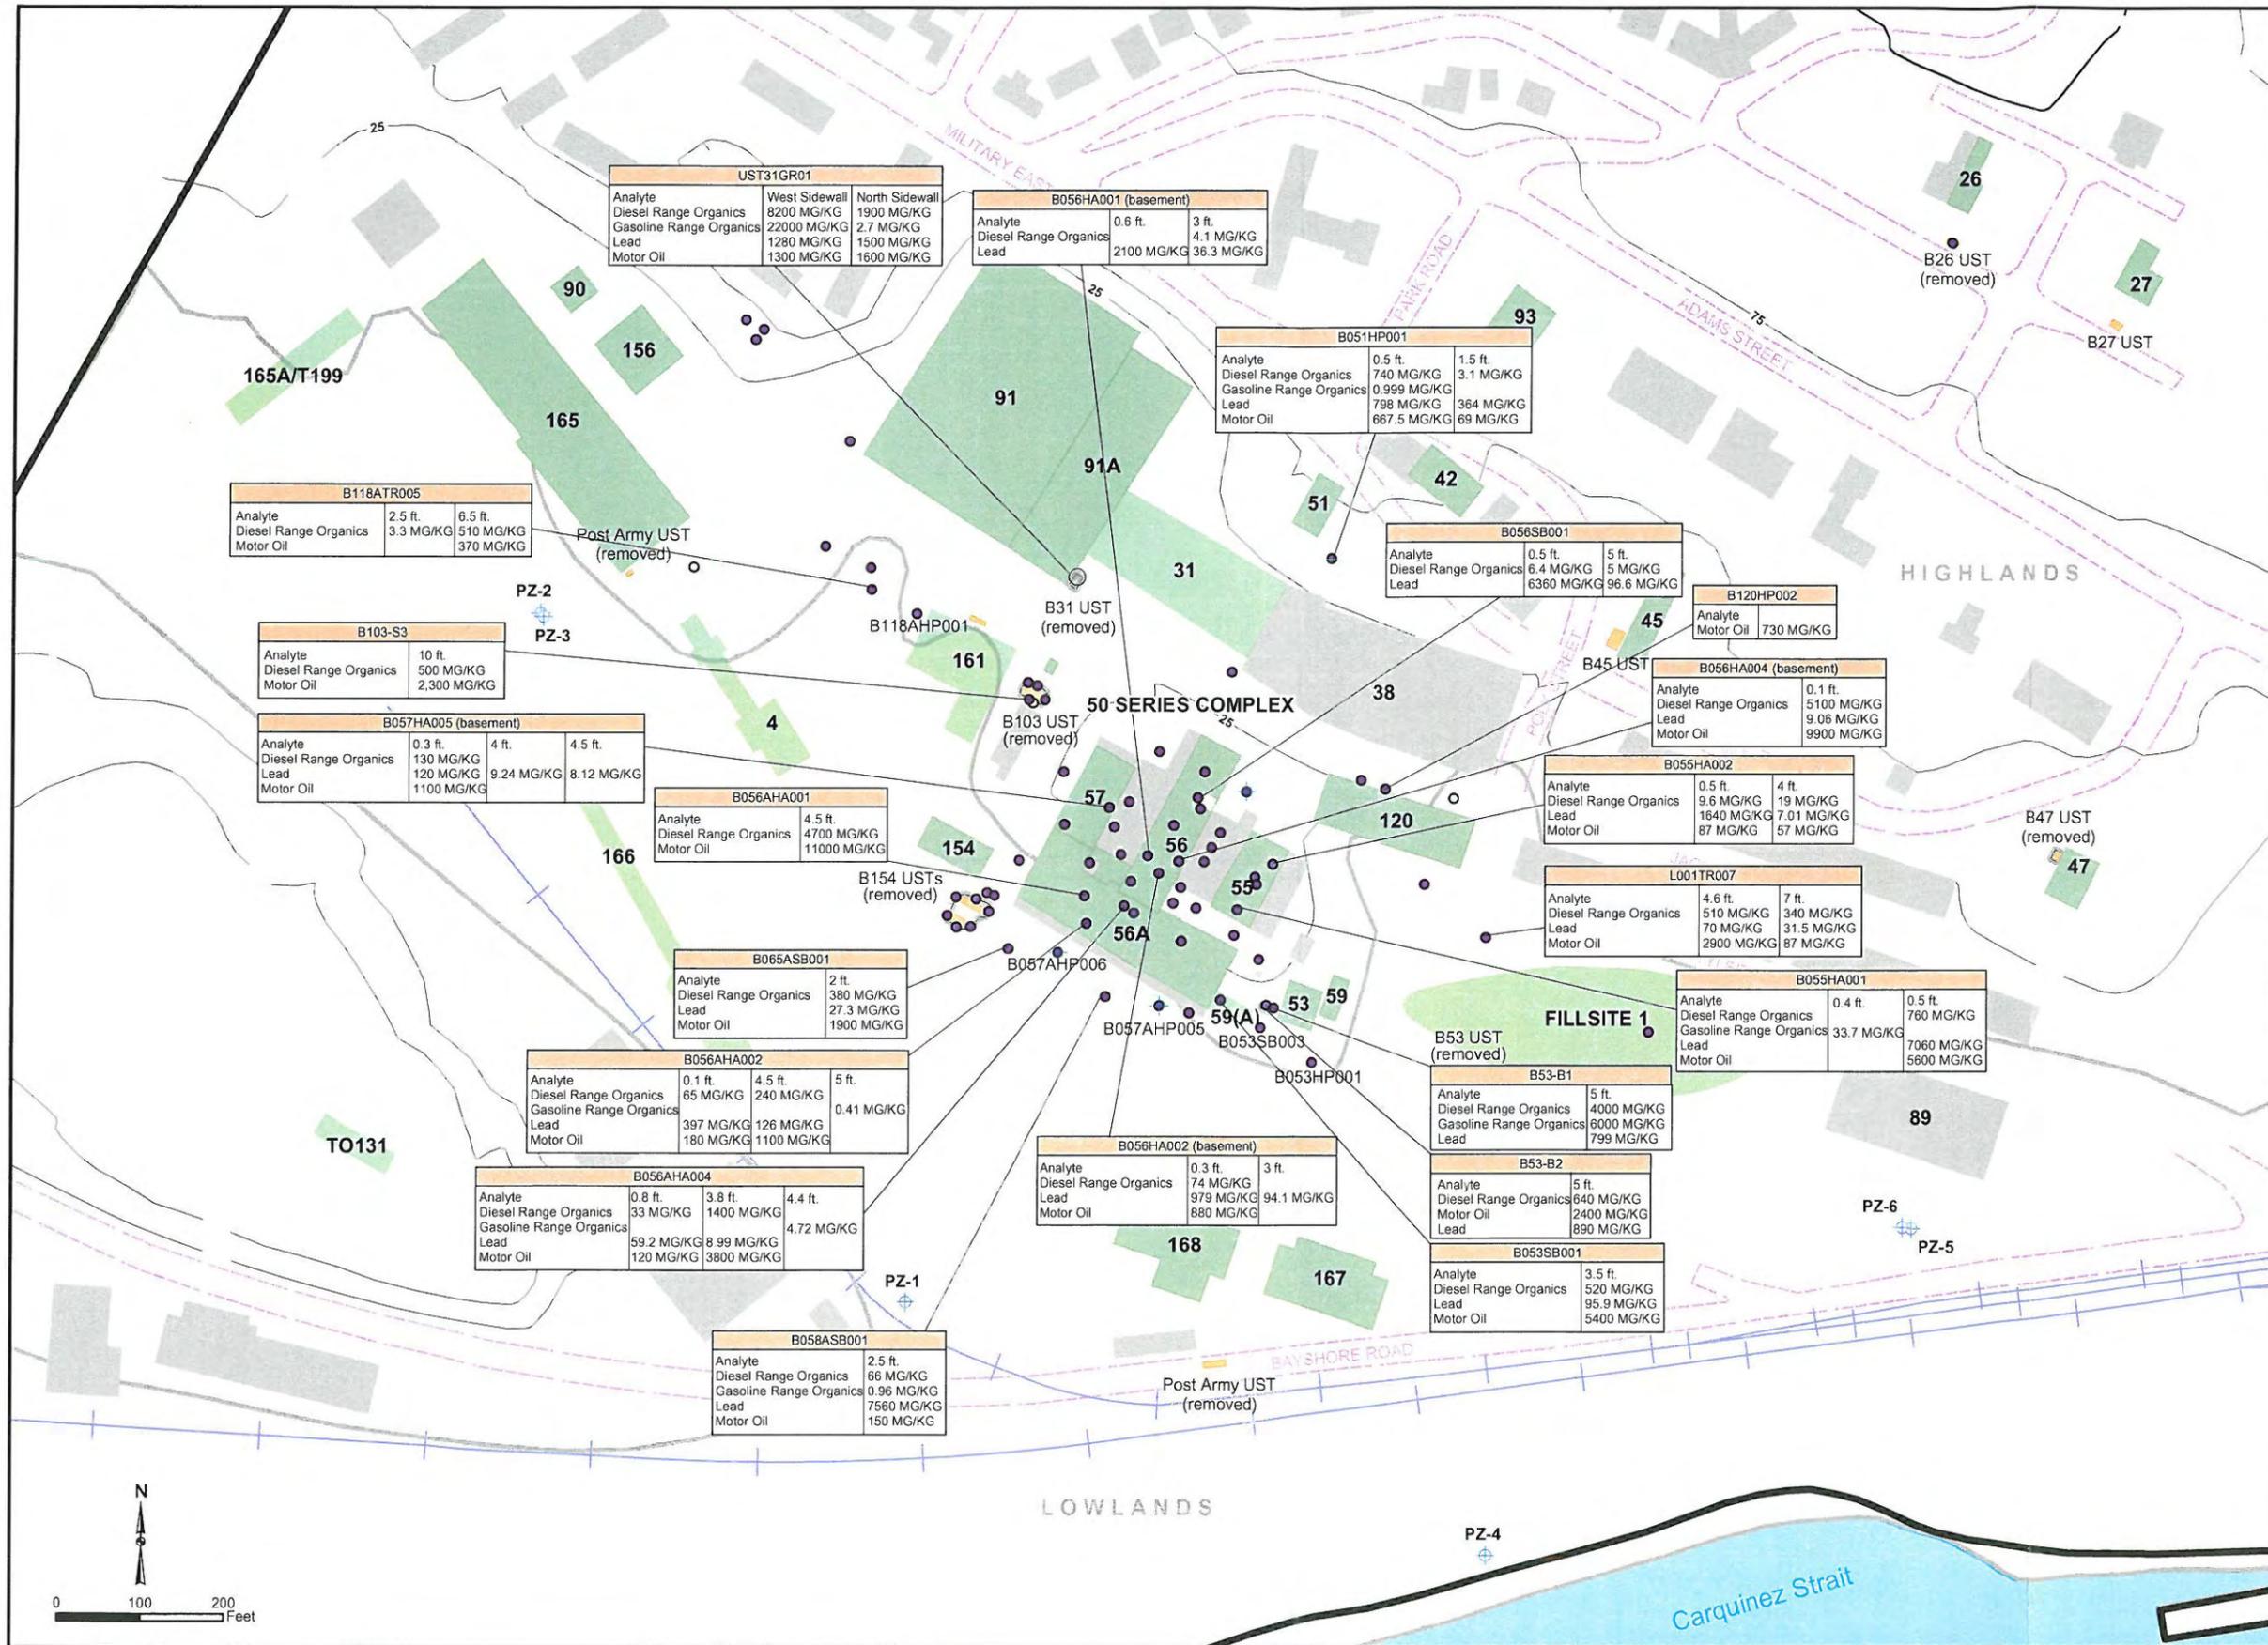
Dissolved lead was present in groundwater collected in the excavation during the UST removal at a concentration of 0.19 mg/L, which exceeds its ESL of 0.0025 mg/L. Other groundwater samples in the area (B053SB002, B053HP001, B053SB001) have lead concentrations in groundwater below the ESL. Based on their location to the former UST, the lateral extent of lead has been defined in groundwater.

Analysis of the groundwater sample collected in boring B053HP001 did not report any hydrocarbons, toluene, TCE, cis-1,2 DCE or vinyl chloride above laboratory MDLs. Groundwater samples collected approximately 100 feet downgradient of the former excavation detected TCE and toluene at B059AHP001. Toluene was detected at 2.7 µg/L and TCE at 1.3 µg/L.

Plate 1, Figure 6-15, and Figure 6-16 show the extent of diesel fuel, gasoline and motor oil in groundwater and have been defined to their respective ESLs. The reported TCE concentration in B059AHP001 is part of a larger solvent plume (see Plate 2) and is discussed in Section 6.5.27. A risk assessment is recommended for impacted groundwater from the former Building 53 UST.

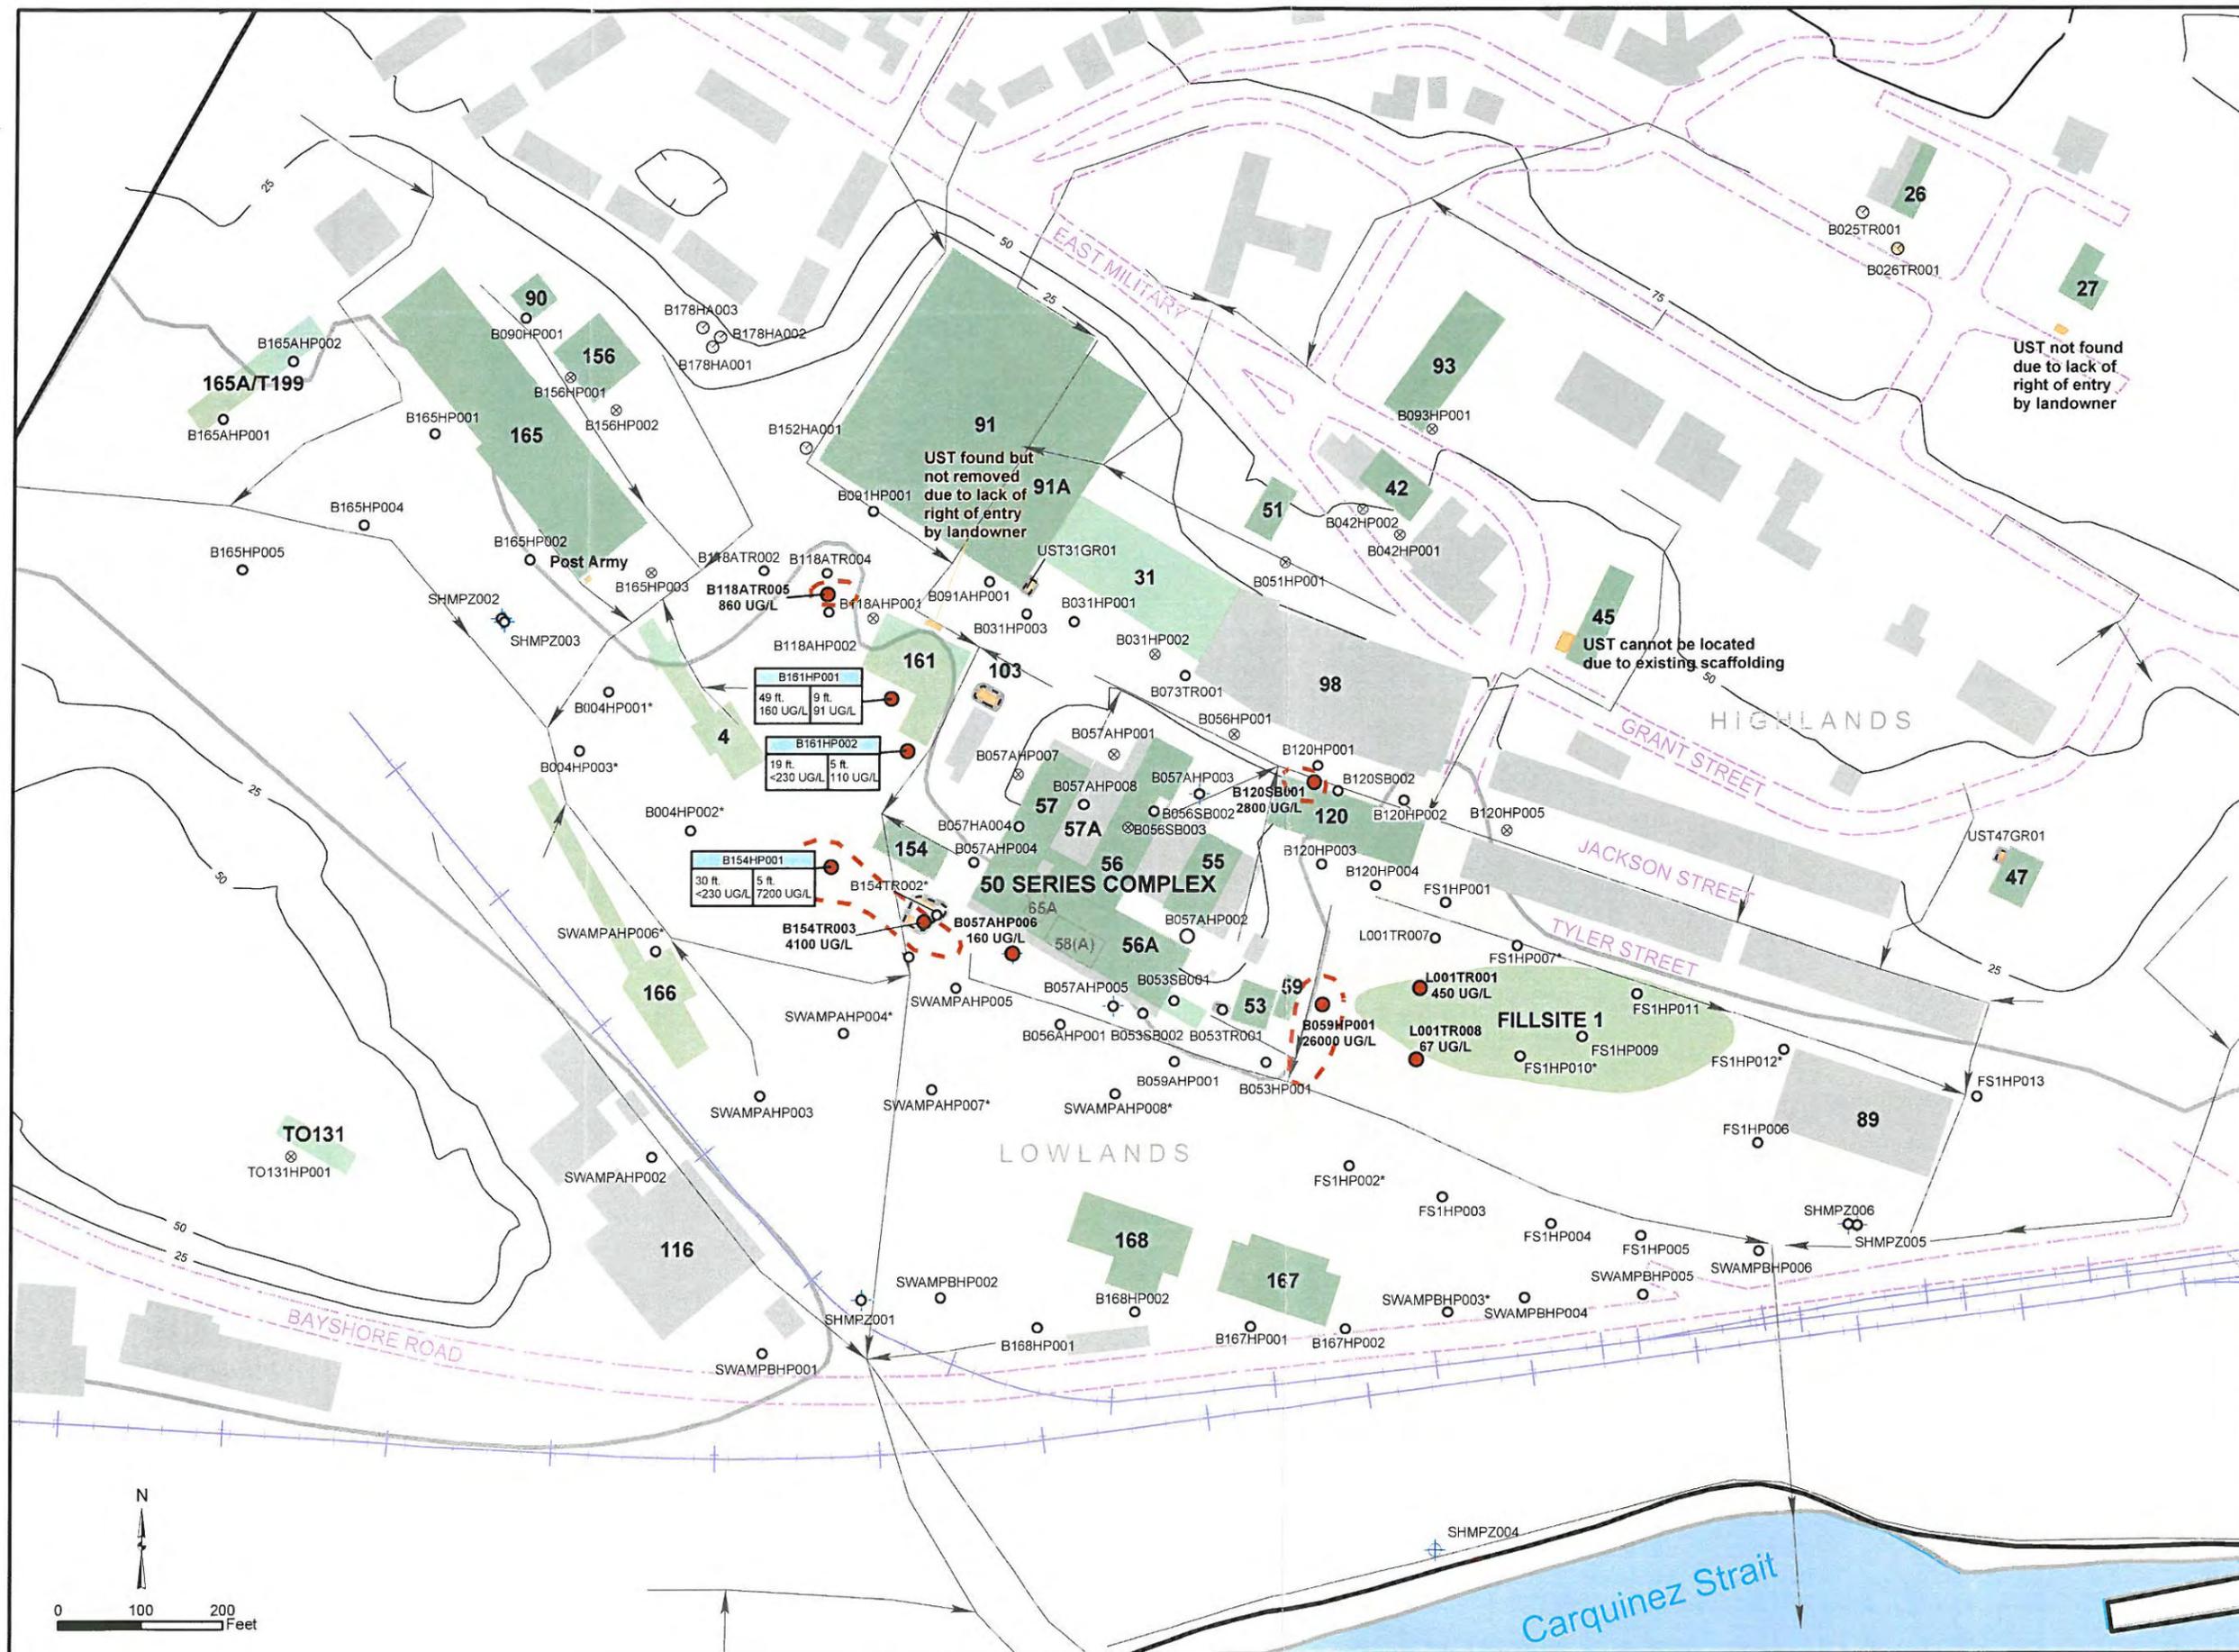
**Figure 6-16**  
**Motor Oil Detected in Groundwater**  
 SITE:  
**Benicia Arsenal, Benicia, California**

Motor oil was only detected in shallow groundwater at B059HP001 (Figure 6-16). The lateral extent of motor oil was drawn assuming that the storm drain line intercepts the motor oil impacted groundwater in this area (Figure 6-16).

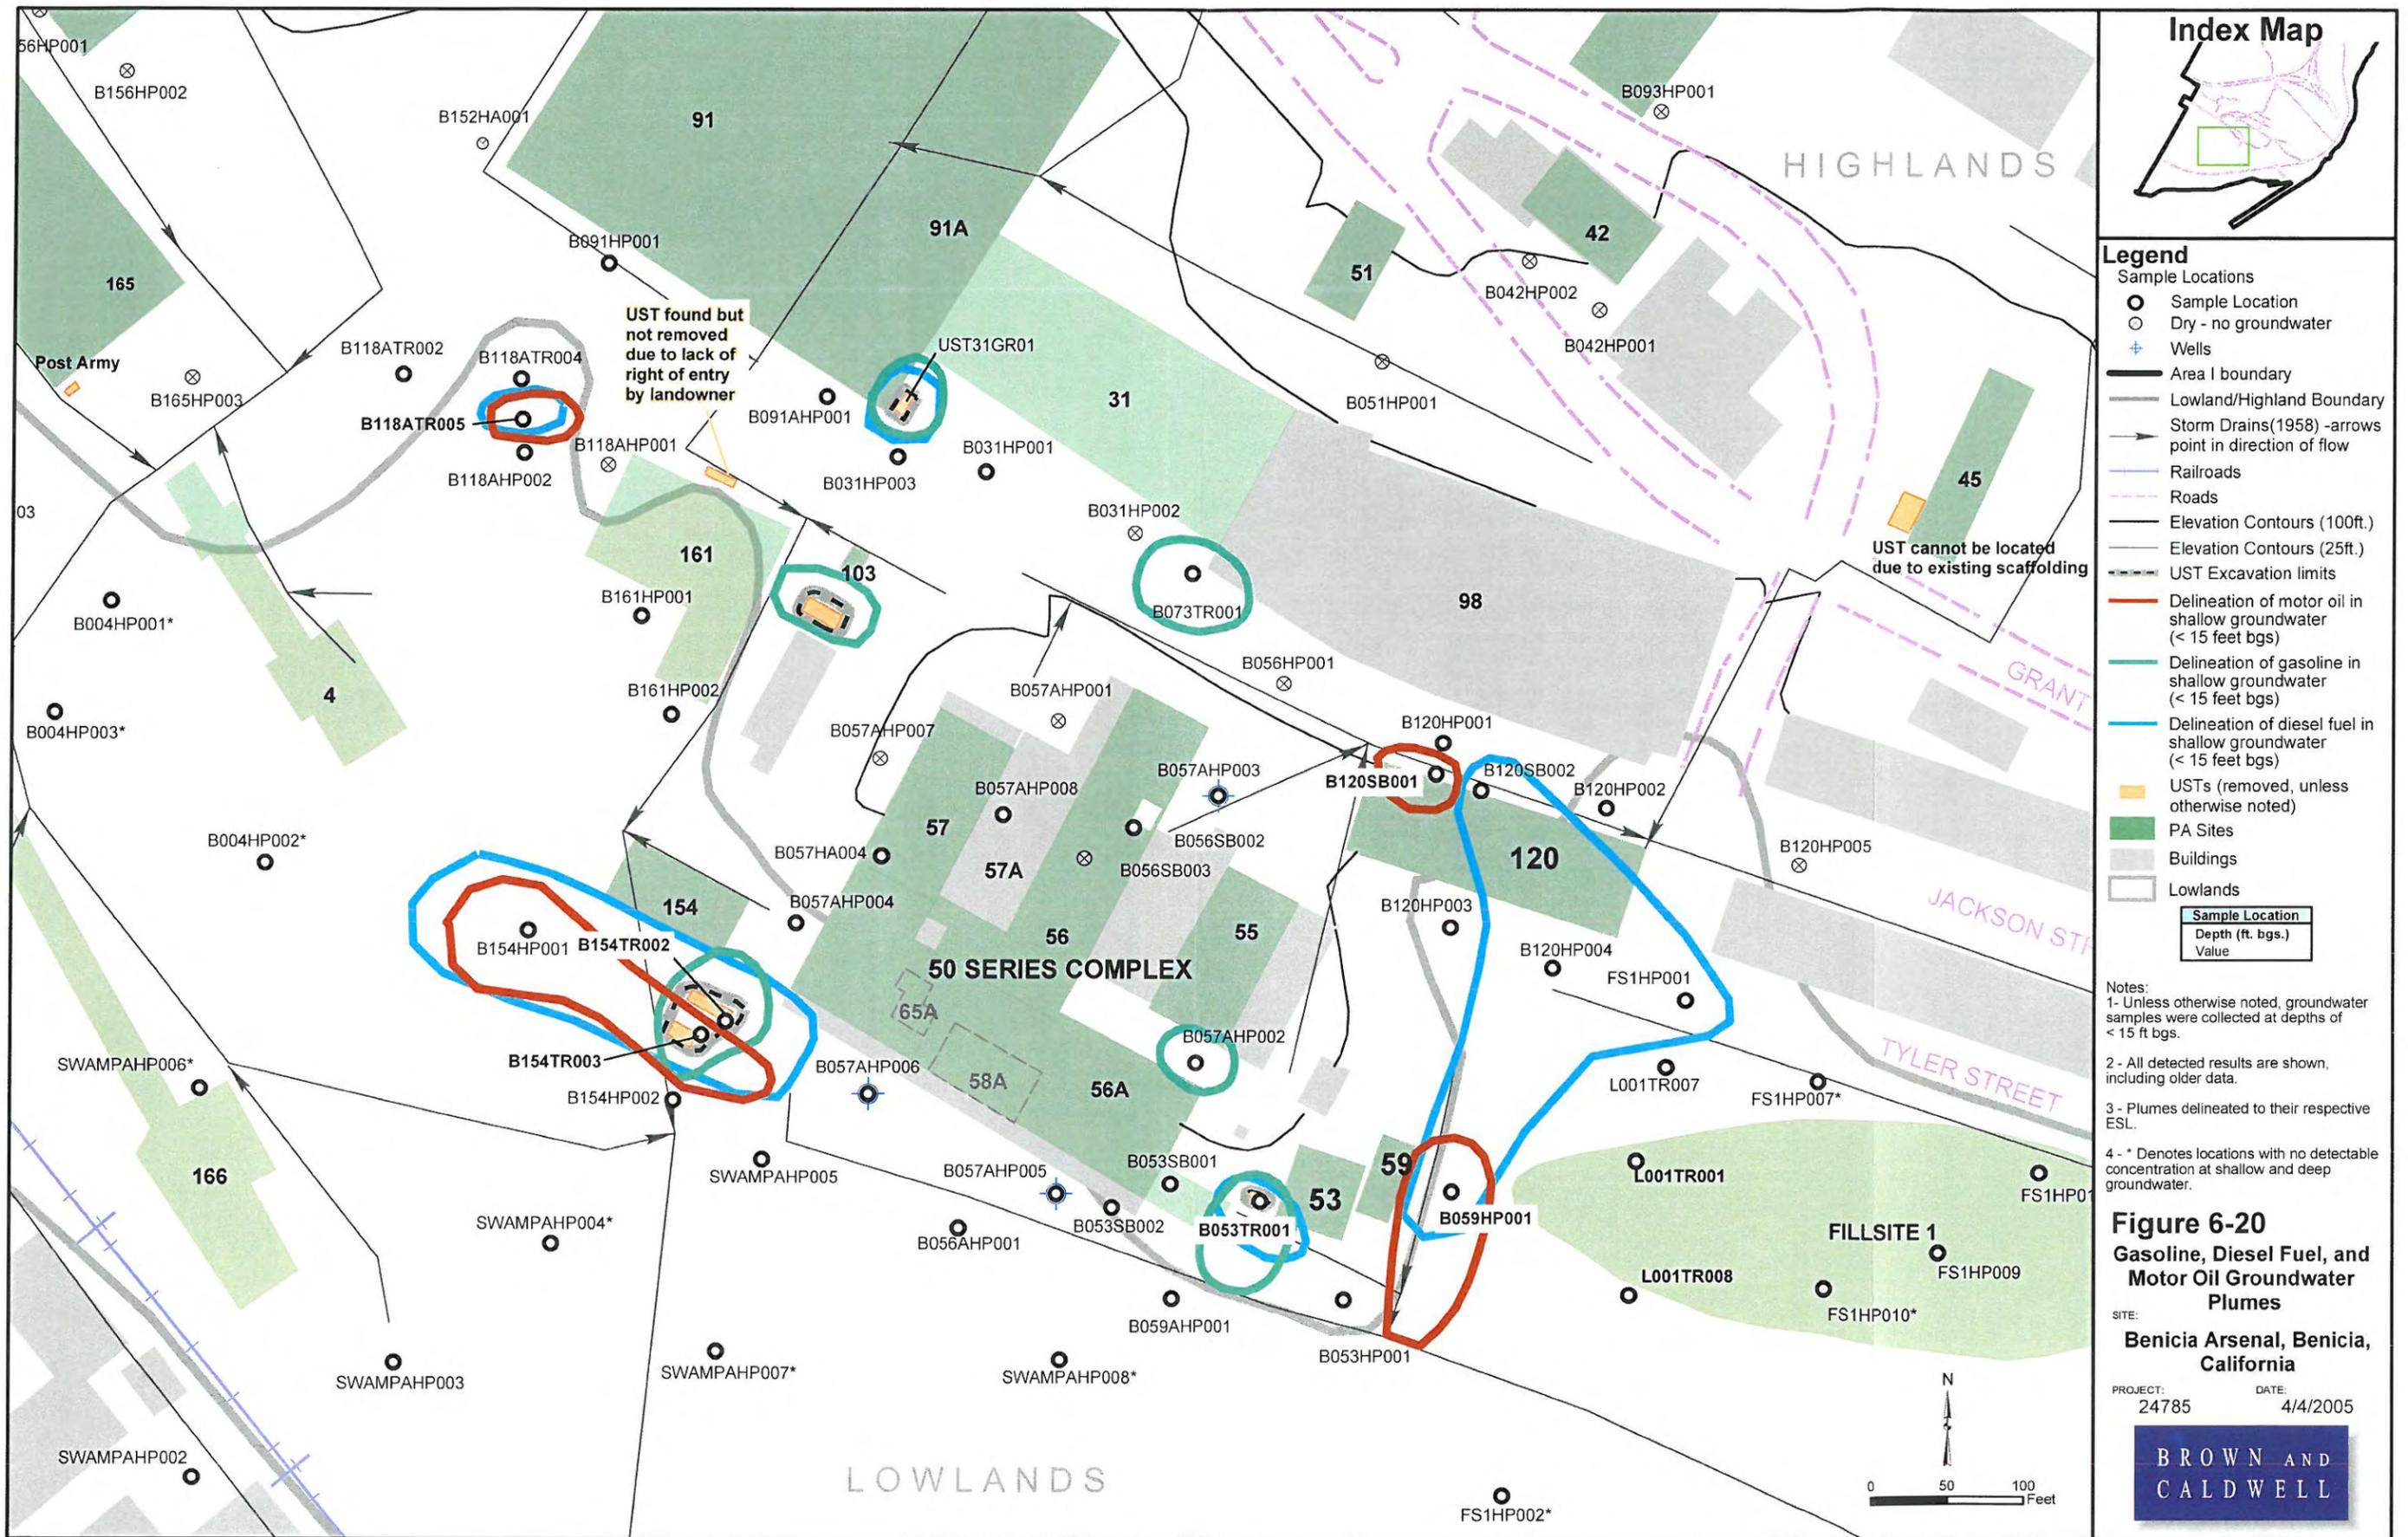
- Motor oil was also detected in shallow groundwater samples collected near Building 59 (Figure 6-16). This building was used as a tool house. In 1951, a degreaser pit was installed. After the Army left, the building was used as a machine shop where cutting oils may have been used. After the Army left in 1964, the building was also used as machine shop. The source of the motor oil is unknown.

- Diesel fuel and motor oil was reported in B118ATR005 at a concentration of 2,700  $\mu\text{g}/\text{L}$  and 860  $\mu\text{g}/\text{L}$ , respectively, during a previous investigation (FA/BC, 2002b) (Plate 1 and Figure 6-16). The lateral extent is defined within the area of the boring (Figure 6-20) based on concentrations of diesel fuel and motor oil that are less than ESLs at B118ATR004 and B118AHP002 step-out samples. The source may be attributed to a small release from the former ASTs.
