## SECTION 6 RESULTS AND ANALYSIS

## 6.1 Area R

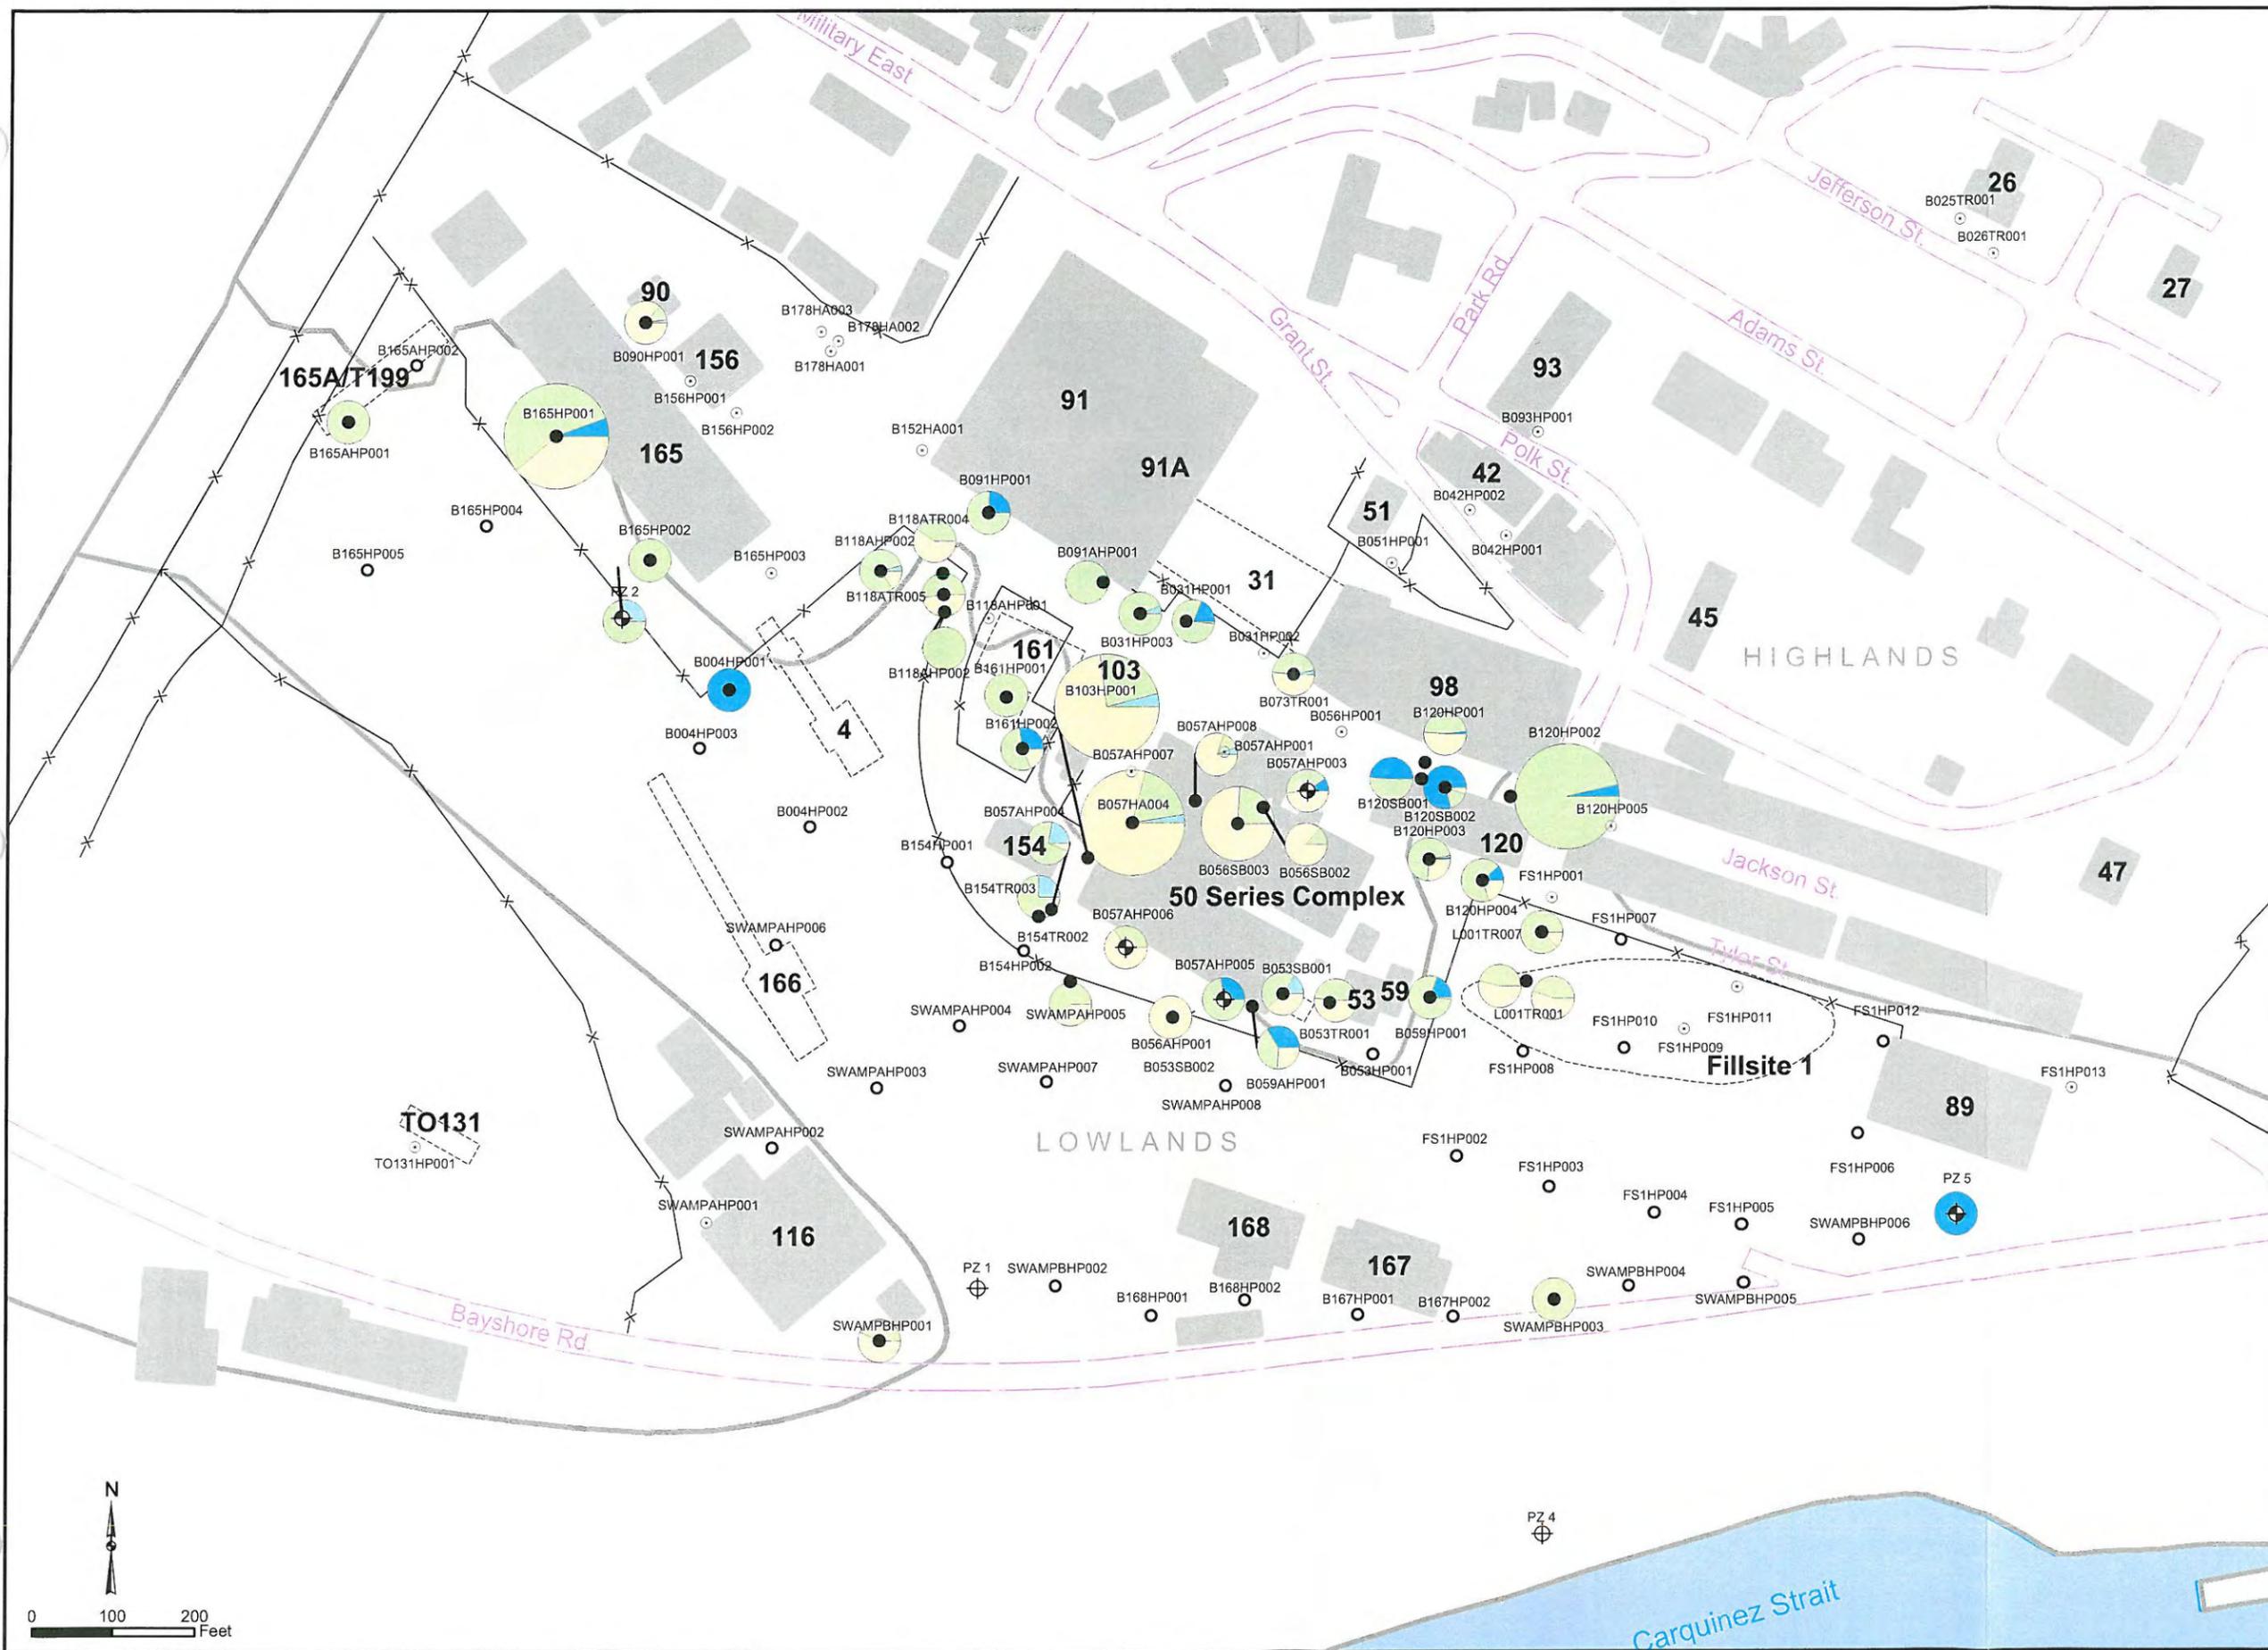
**Figure 6-24**  
 Distribution of TCE and Degradation Products (<15 feet bgs.)

Figure 6-24 is a graphical representation of groundwater concentration of TCE, cis-1,2-DCE, trans-1,2-DCE, and vinyl chloride (VC) for groundwater samples collected at less than 15 feet bgs, which represents samples collected within the artificial fill and the alluvium north of the Complex. Figure 6-25 illustrates the same concentrations except for samples collected at greater than 15 feet bgs. These deeper samples were collected from the alluvium beneath the Bay Mud and at the contact between the alluvium on the north side of the Complex and the sandstone. All of the historic data and the Expanded SI data are included in these figures.

The composition of samples shown on Figure 6-24 reinforces that there were separate releases of TCE and distinct plumes near Building 165, the 50 Series Complex, and Building 120 as described in Section 6.5.27.3. The groundwater samples near Building 165 indicate a relatively small plume with a source area near B165HP001 that extends downgradient to approximately B004HP001 near Building 4. This distinct group of samples illustrates a typical TCE plume with primarily TCE at the head of the plume (i.e., source area), biodegradation products cis-1,2-DCE with some trans-1,2-DCE near the middle of the plume, and primarily VC at the toe of the plume. Note that the concentration of total VOCs decreases along the plume axis several orders of magnitude. A different pattern (i.e., "fingerprint") of contaminant composition appears in Figure 6-24 near the 50 Series Complex. Samples near the 50 Series Complex, which is perched on a highland knoll, are composed predominantly of TCE with some cis-1,2-DCE. Samples in the surrounding lowlands downgradient of the 50 Series Complex are composed primarily of biodegradation products of cis-1,2-DCE and vinyl chloride. The presence of TCE with few daughter products or cis-1,2-DCE at relatively low concentrations underneath the 50 Series Complex may indicate a more recent TCE release or inherent subsurface conditions that are less conducive to anaerobic biodegradation. Near Building 120, the pattern differs from the 50 Series Complex with a composition of primarily cis-1,2-DCE and VC with lesser concentrations of TCE. The plume near Building 120 is unlikely to be from a source area at the 50 Series Complex because detections in between are orders of magnitude less in concentration.

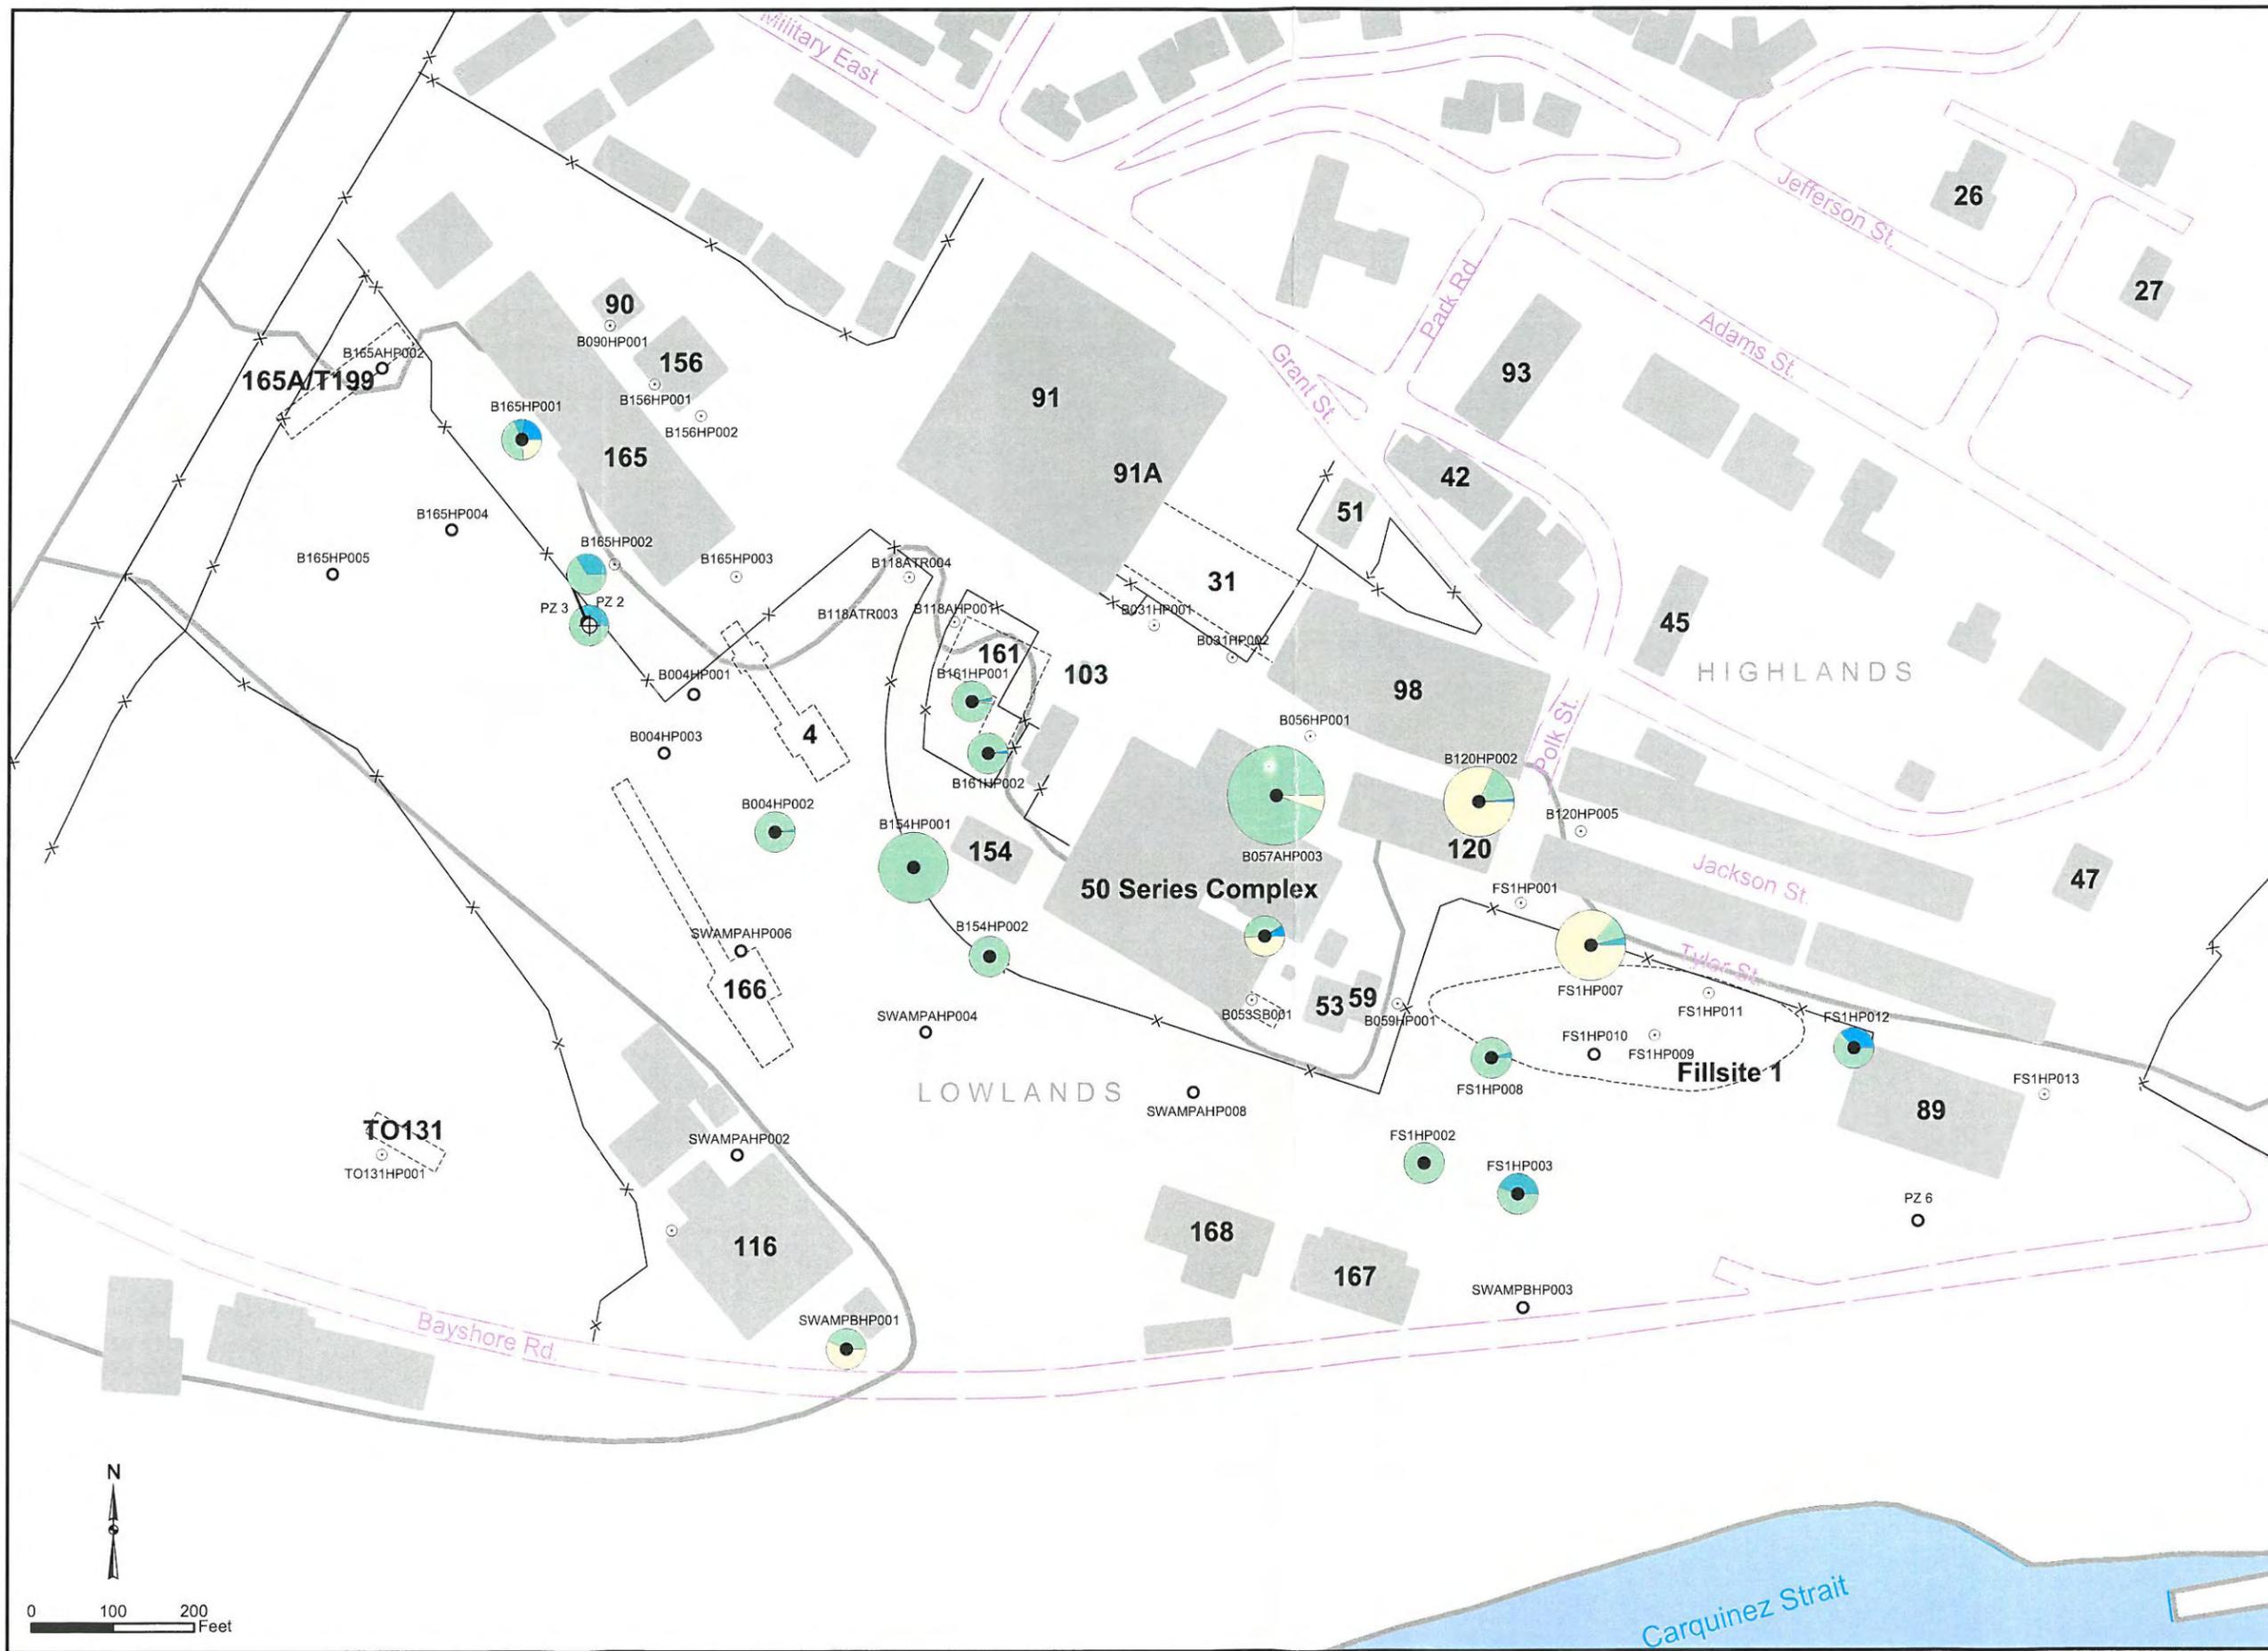
The composition of samples shown on Figure 6-25 indicates deep groundwater solvent contamination in the same three source areas as identified in Figure 6-24. The composition of
