EXPANDED SITE INSPECTION ADDENDUM REPORT

Environmental Investigation at the Formerly Used Defense Site (FUDS)
at the former Benicia Army Arsenal, Benicia, California
FUDS Number: J09CA075600

DRAFT FINAL

June 2006

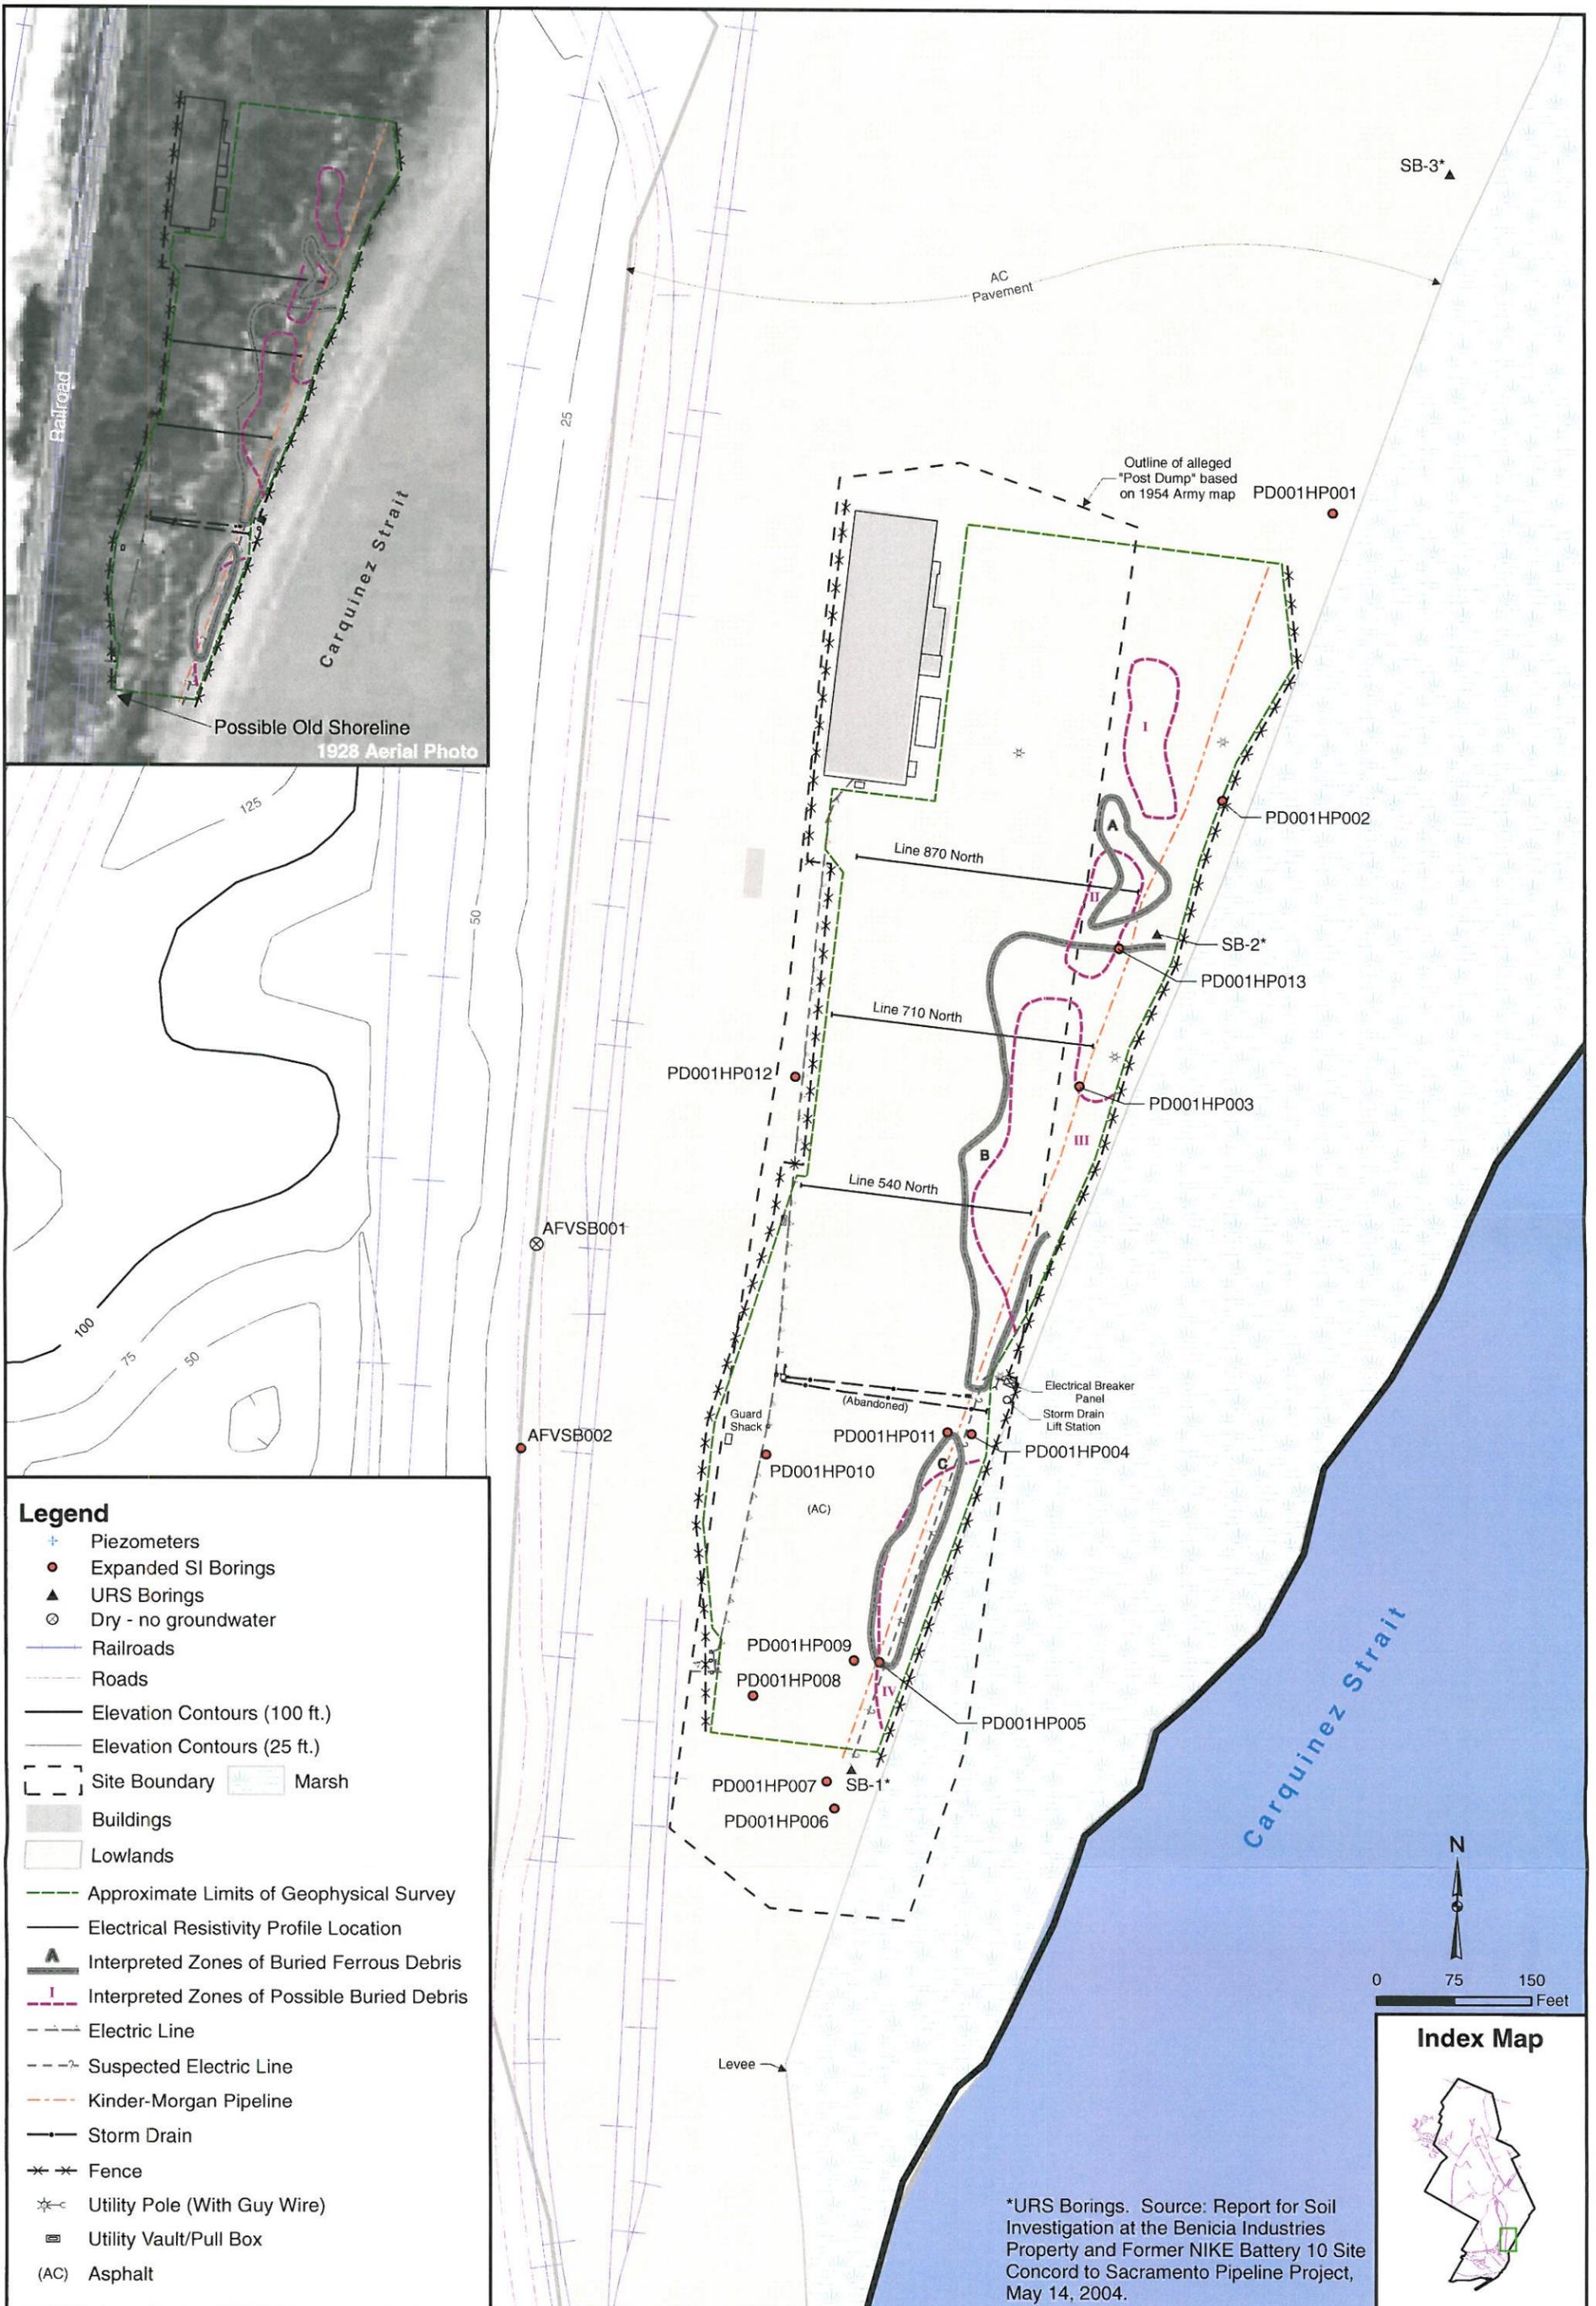
The interpreted results from the VMG, TC and metal detector data are provided on Figure 3-1. There are a total of six zones identified; three gray-outlined areas, labeled “A” through “C”, and three red-dashed outlined areas, labeled “I” through “IV”. These zones are orientated parallel to the levee and not more than 100 feet wide. These areas are interpreted to be zones of possible buried ferrous debris (A through C) and zones of buried debris (I through IV). Existing subsurface structures found by the survey included storm drain lines, a buried electrical line, and the Kinder-Morgan pipeline (Figure 3-1). The Kinder-Morgan pipeline is located parallel to the levee and within these anomalous zones.

In 1928, the area of the alleged Post Dumpsite was undisturbed land. This photo and the anomalous areas identified during the geophysical survey were overlaid on top of the 1928 photo, as shown on Figure 3-1. The anomalous areas are positioned west of the 1928 shoreline and east of an irregular white line. This white line could represent high tide. The dark material on the photo is vegetation. It is presumed that the anomalous areas are likely construction debris that was pushed into this area as a means to support the existing paved surface and/or a foundation for the existing levee. The location of the levee coincides with the eastern extent of the survey area and is also located at the boundary between the marsh and the paved area.

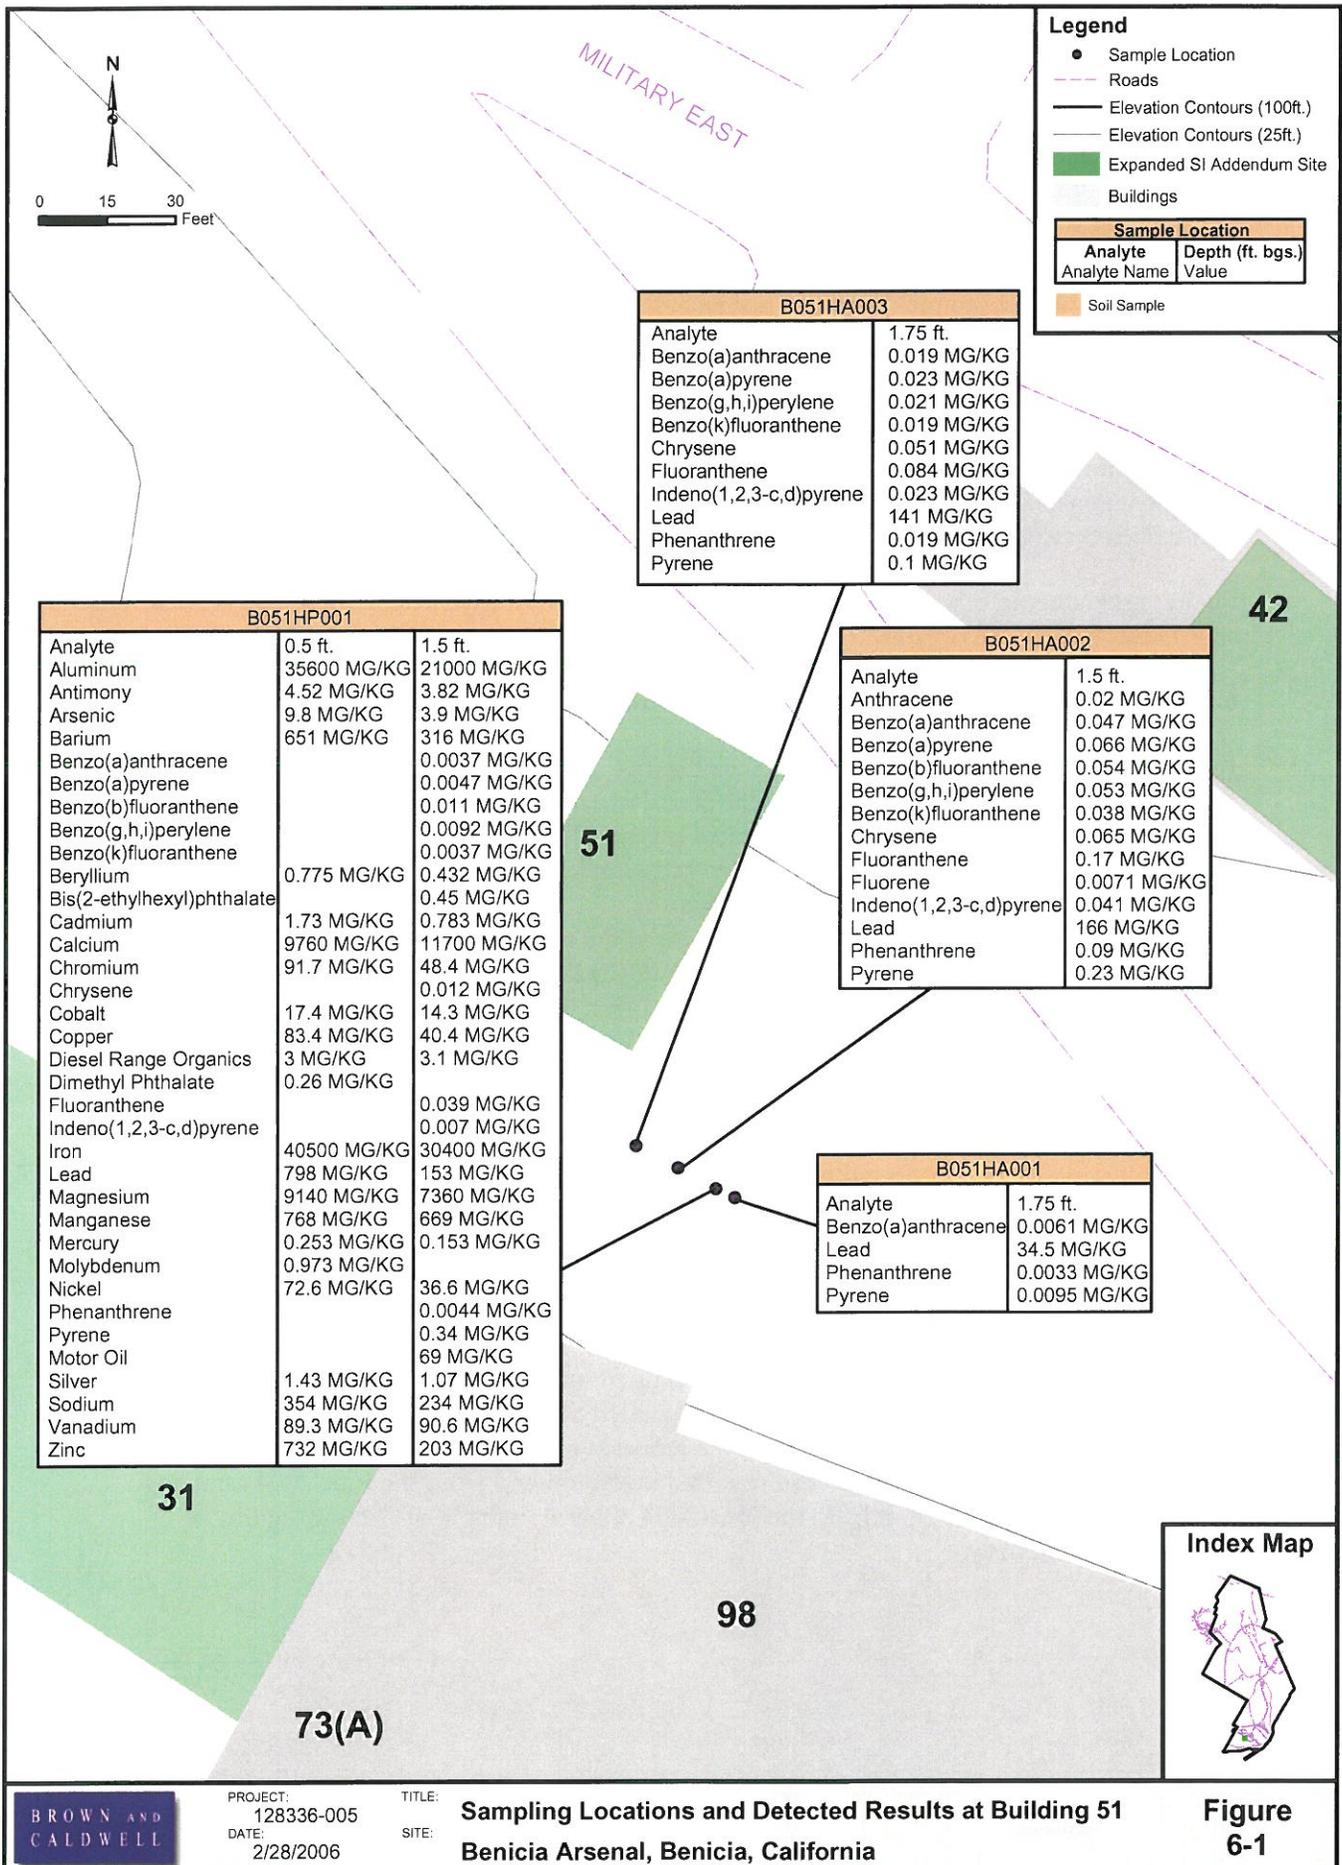
Detected results of all samples collected at Building 51 are shown on Figure 6-1. A comparison of the lead data from this investigation and the Expanded SI also is provided in Table 6-1.

Concentrations of lead are consistent with the reported results in the Expanded SI Report, around 150 mg/kg (BC, 2005a). Since the lead reported in shallow soil from the June 2004 sampling location is below the RWQCB ESL, the June 2004 duplicate sample of 798 mg/kg can be considered an anomaly.

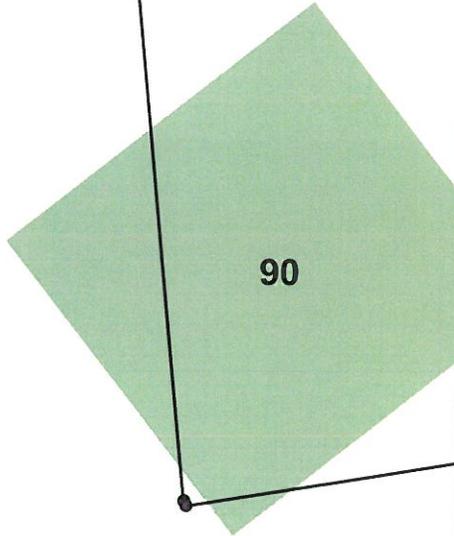
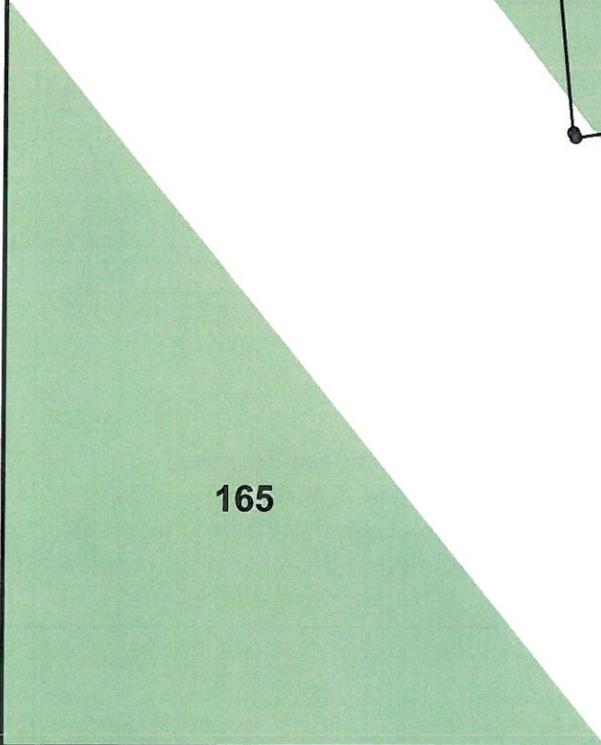
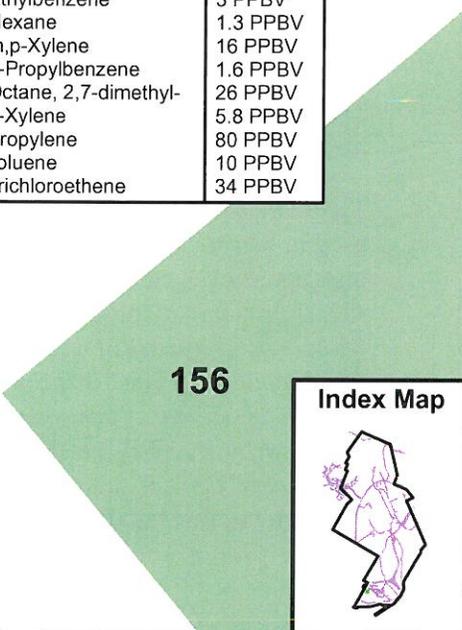
Figure 6-2

The groundwater sample collected from Expanded SI boring B090HP001 contained diesel fuel, cis-1,2 DCE, and TCE at concentrations of 97 µg/L, 13 µg/L, and 96 µg/L, respectively (BC, 2005a) (Figure 6-2). A building is adjacent to the groundwater sample location, therefore, a soil gas sample was collected. The complete list of detected VOCs in soil gas is shown on Figure 6-2, and the constituents with ESLs are shown in Table 6-3 below.

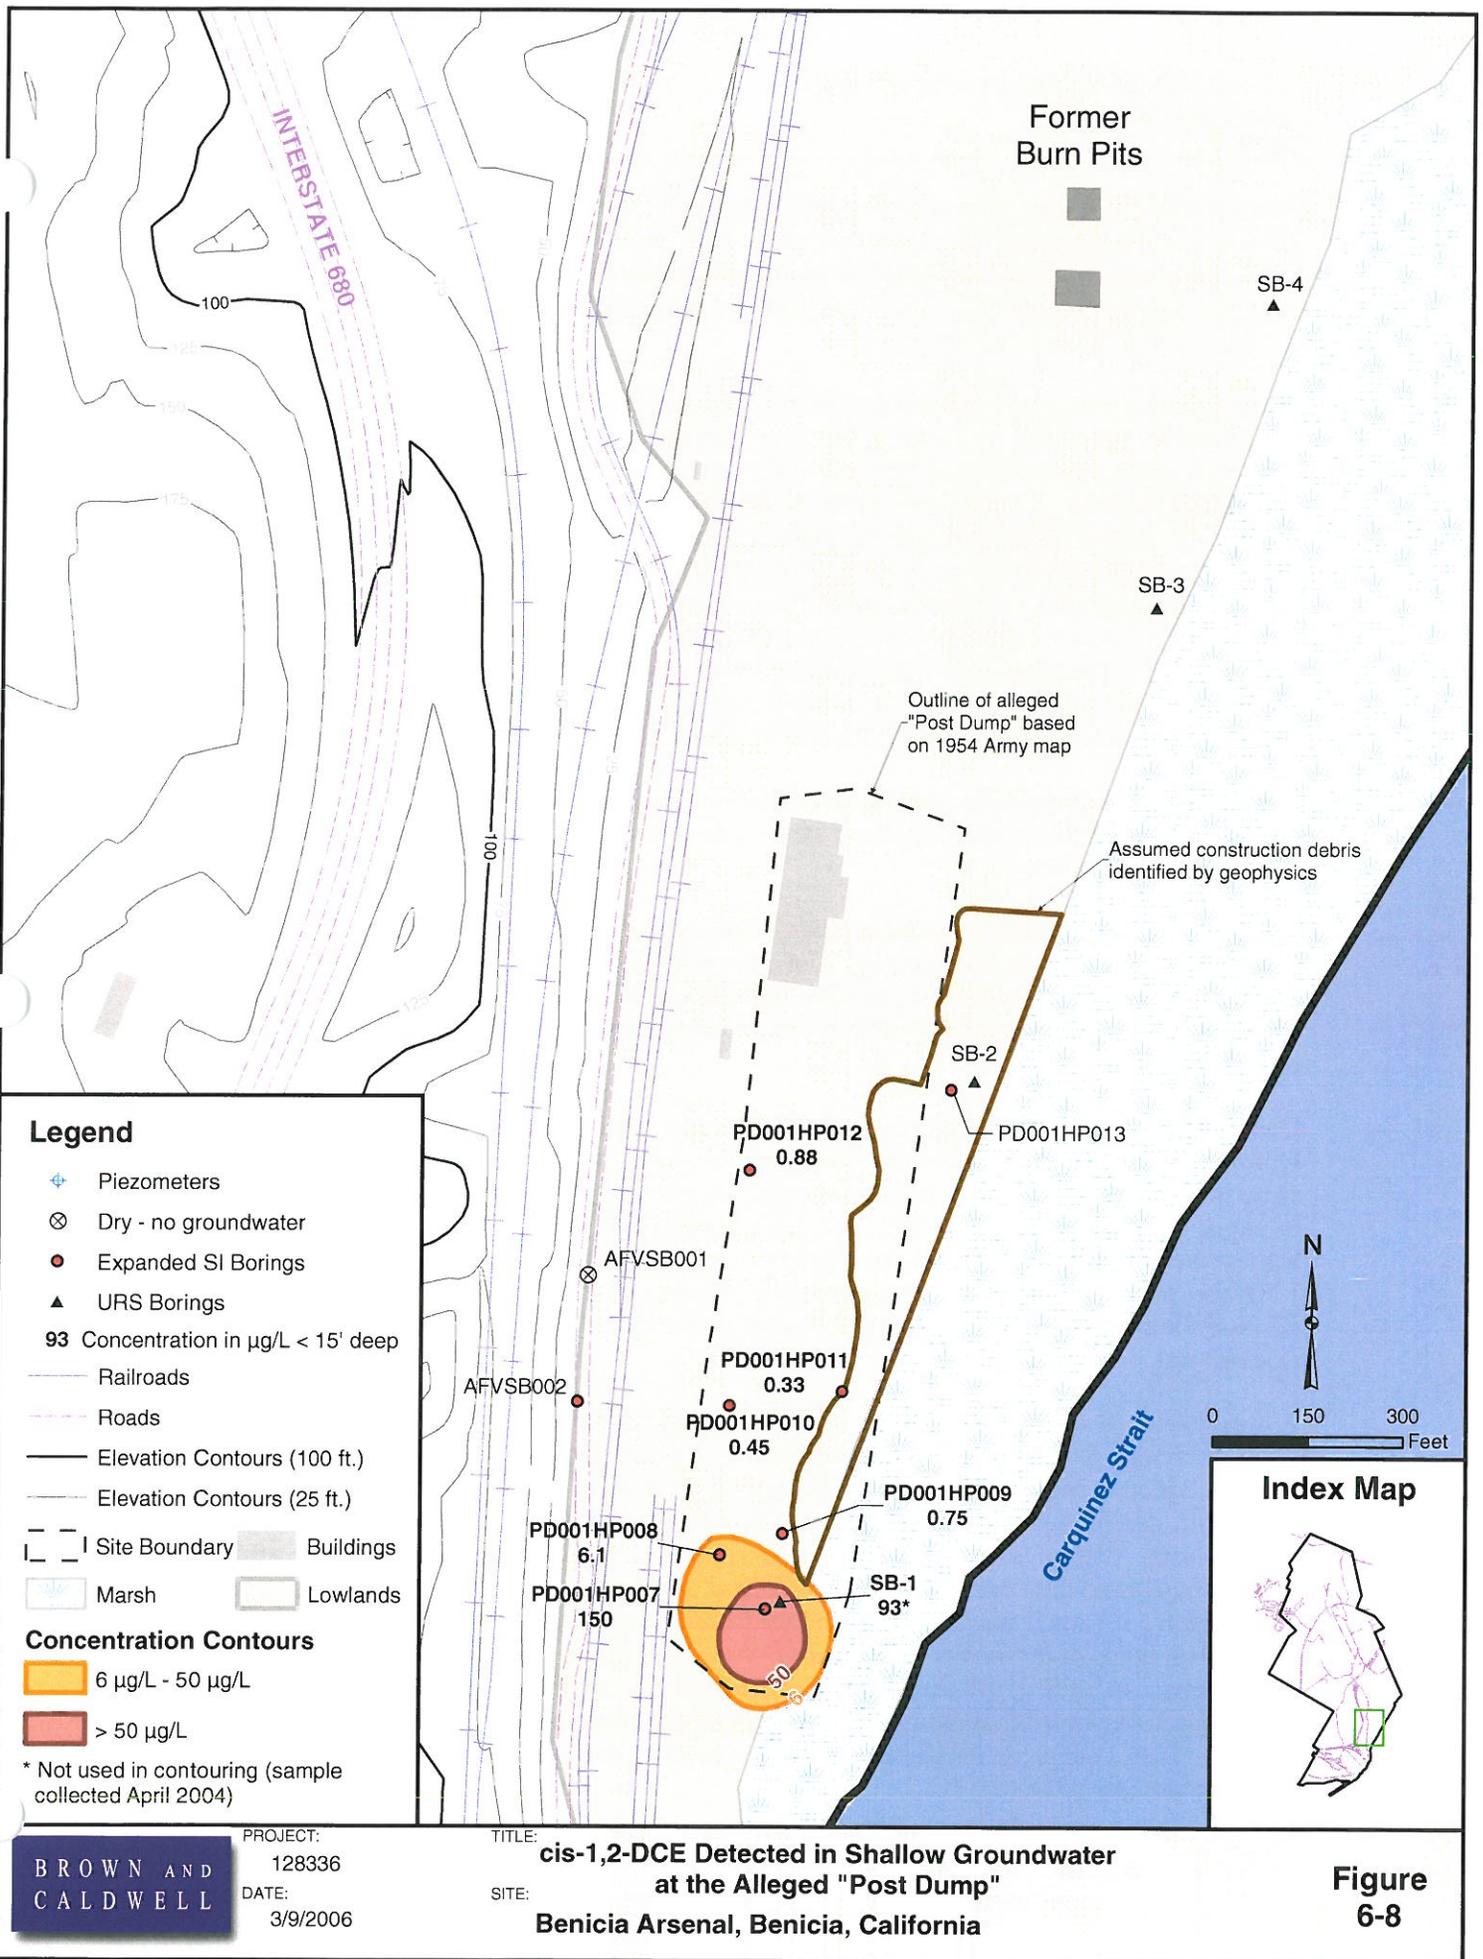
Figure 6-8

TCE was found in shallow groundwater at PD001HP009 at concentrations of 0.24 µg/L, shown in Figure 6-7. No groundwater samples exceeded the TCE ESL of 360 µg/L. Groundwater samples containing cis-1,2 DCE were detected in six of the seven borings advanced (Table 6-6 and Figure 6-8) as shown on Figure 6-8, the highest concentration of cis-1,2 DCE is at the southern end of the alleged Post Dumpsite. Samples collected from PD001HP007 contained a concentration of 150 µg/L. No sample exceeded the RWQCB ESL in soil or groundwater.
