The project would change the refinery's crude slate.

**Example of the project's significant oil quality impacts: hydrogen deficiency.**

Project tar sands oil would cause significant refining impacts.

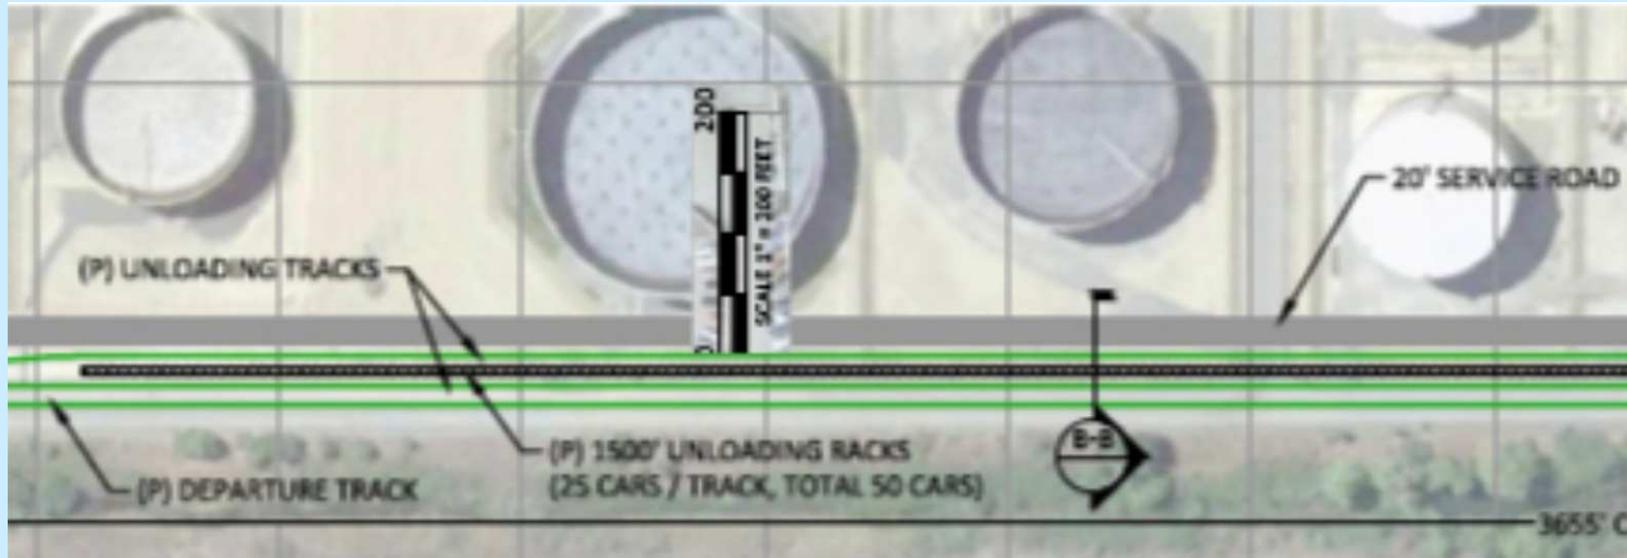
Excerpt from DEIR Figure 3-3. (200 feet grid-scale indicator repositioned for reference.) Project unloading facilities are shown by the horizontal green and black lines on this map.

Too close to existing equipment, the project would create a new knock-on (“chain reaction”) hazard that the EIR ignores.

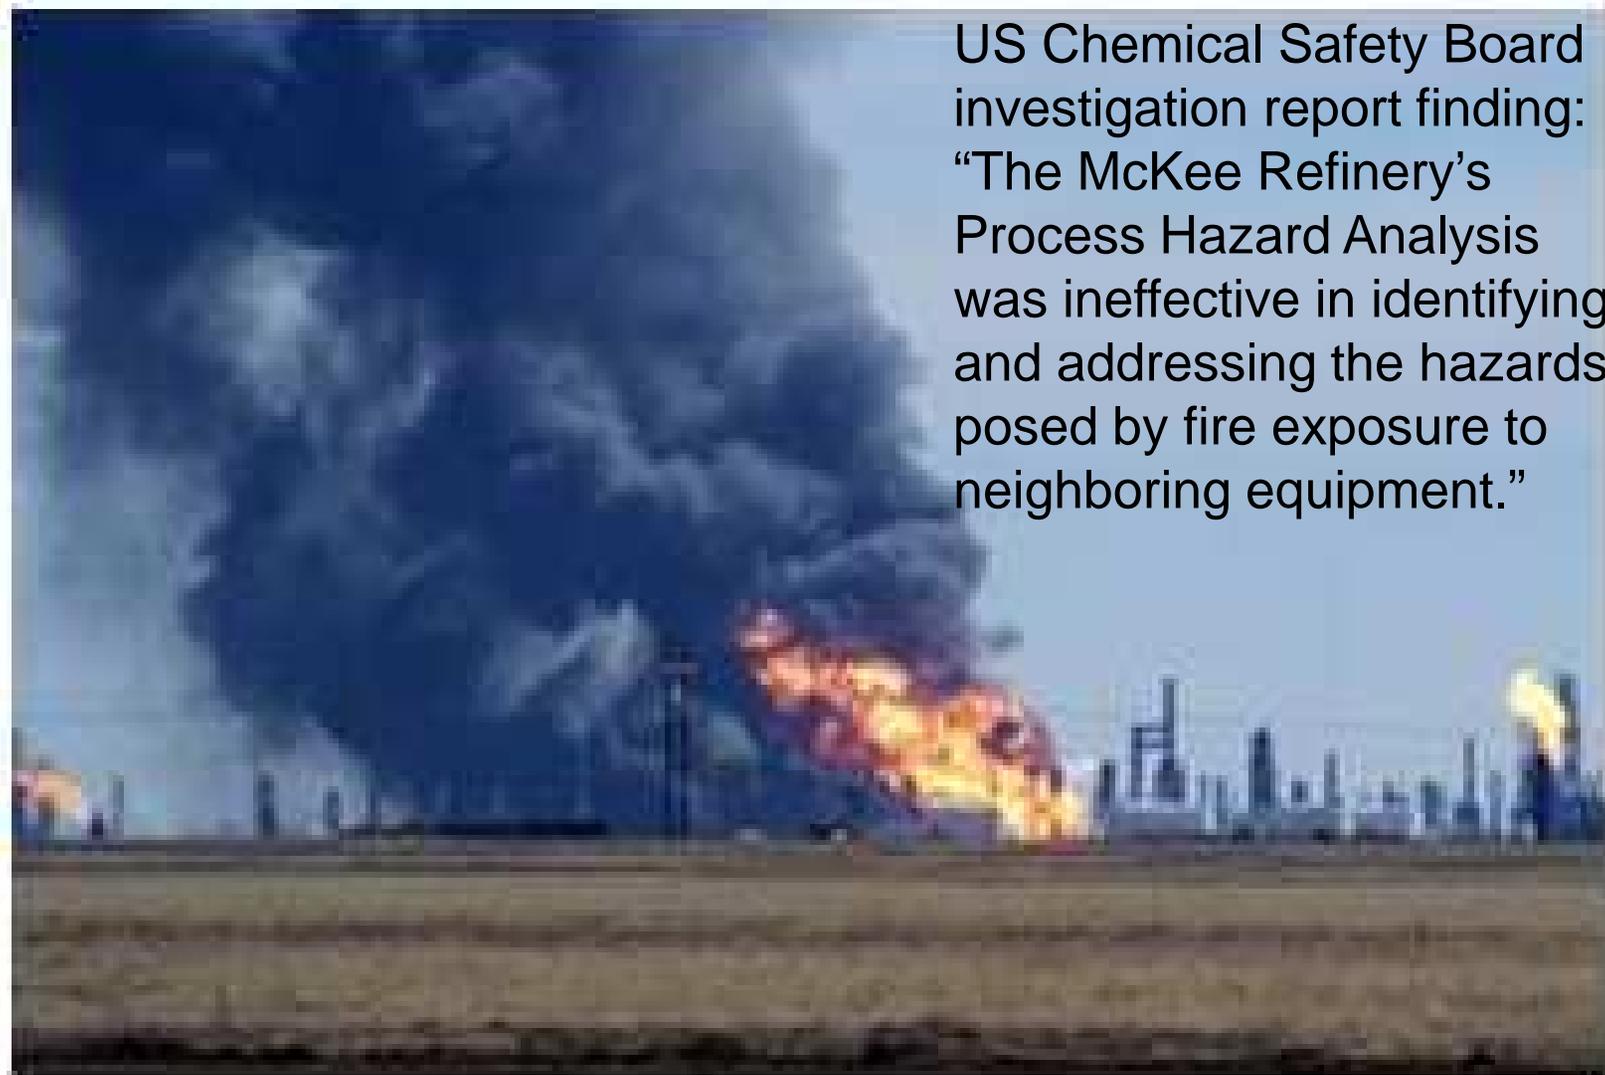
Example: Valero McKee Refinery Fire, 16 Feb 2007.

US Chemical Safety Board investigation report finding: “The McKee Refinery’s Process Hazard Analysis was ineffective in identifying and addressing the hazards posed by fire exposure to neighboring equipment.”

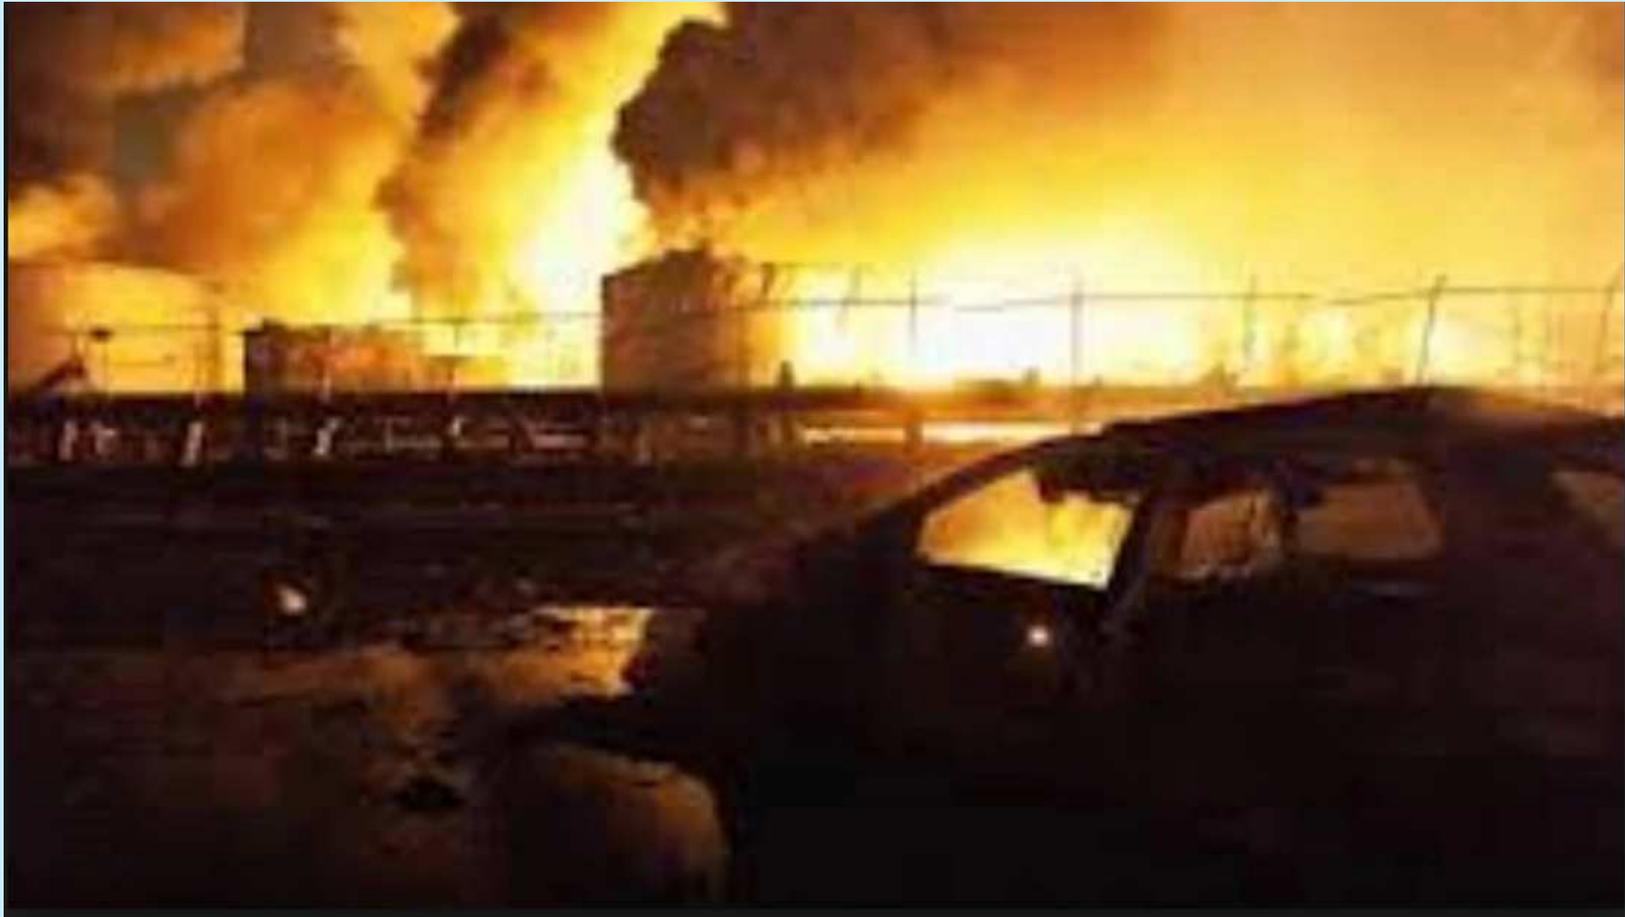
Another example of knock-on (“chain reaction”) incidents:  
PDVSA Amuay Refinery Fire, 25 Aug 2012; 47 people killed.

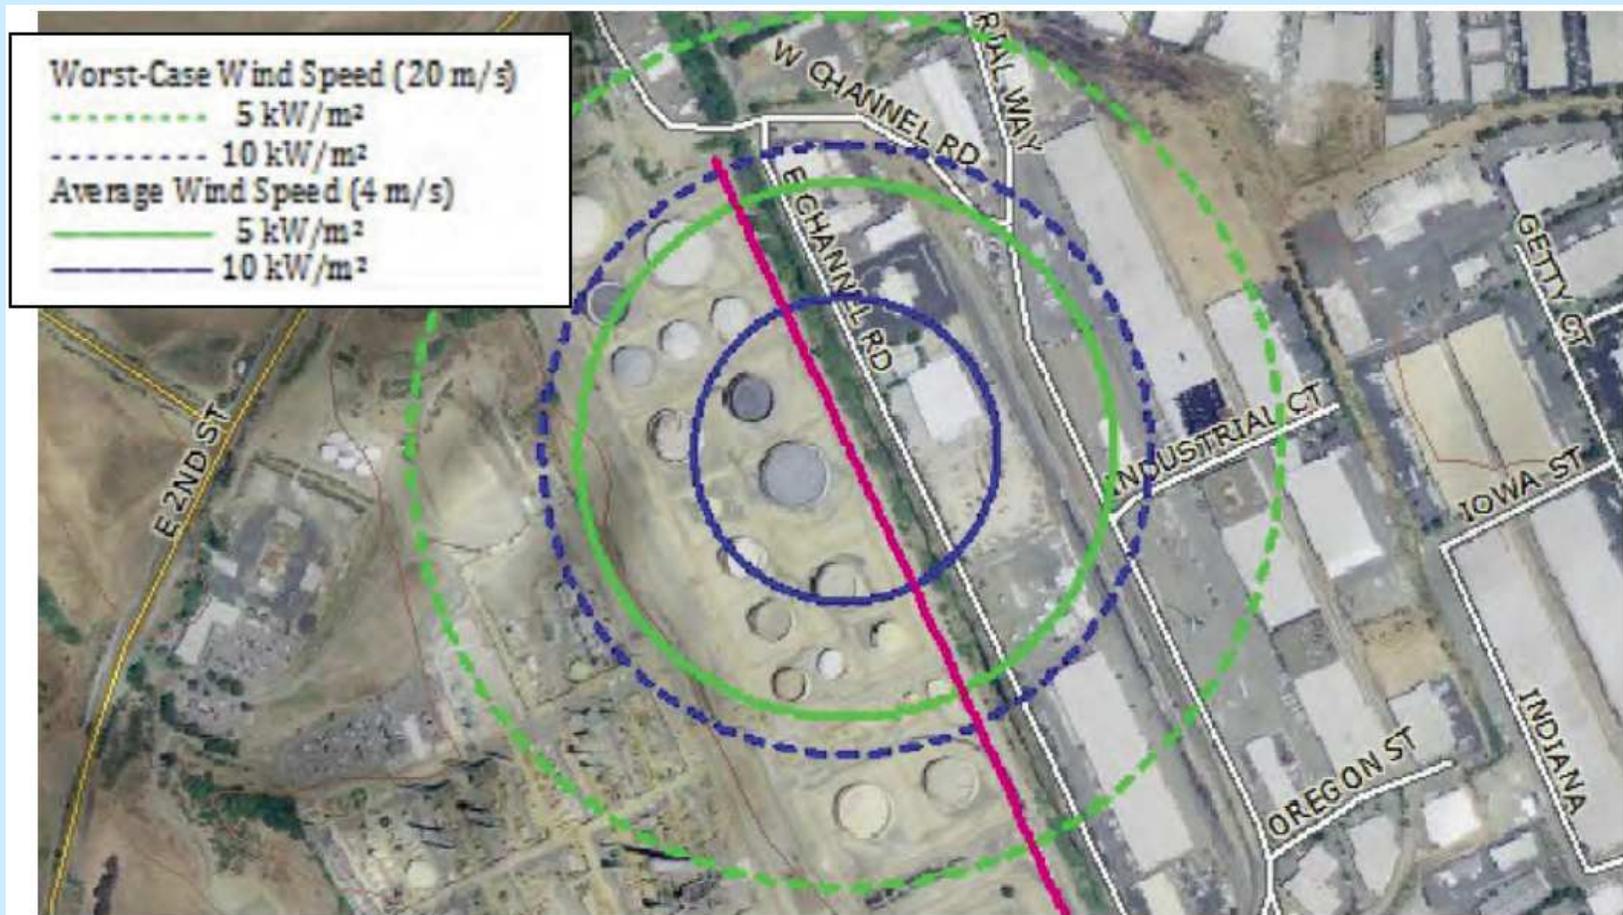
Excerpt from RDEIR Figure 4.7-8. “Worst-Case Facility Thermal Radiation Hazards.” Project unloading facilities are represented by the diagonal pink line on this map.
