PRIMARY RECORD

*Resource Name or State Capitol Building Benicia

b. Address: 103 West G Street

BUILDING, STRUCTURE, AND OBJECT RECORD

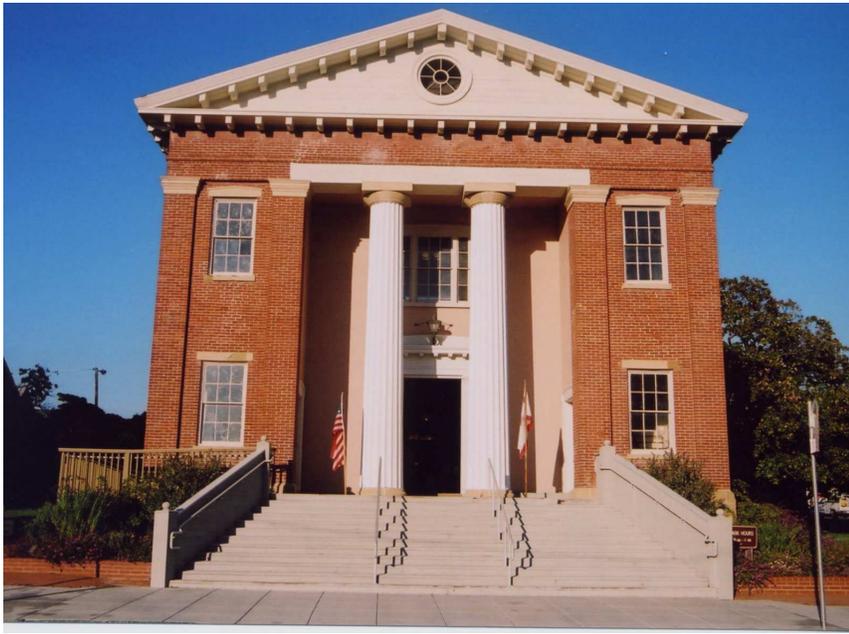
P5. Photograph or Drawing (Photograph required for buildings, structures, and objects.)

This is a stately Greek Revival public building. It is two-story in height with a moderately sloped front gable roof. The roof has wide eave overhangs with exposed rafters. There are wide gable overhangs with exposed purlins. The gable end is embellished with a centrally located circular window. The entry of the building is recessed, set behind a two-story opening with a stone lintel supported on two massive Doric columns. The double entry door is framed by stone pilasters and a flat pediment. The entry is accessed via wide stone steps. Fenestration is symmetrically arranged and consists of six-over-six double hung windows. The building is of brick masonry construction. The building was constructed in 1852 and served as the state capitol from 1852-1853.

P5b. Description of Photo: Front façade, view north
