*Resource Name or #: St Paul's Guild Hall
P1. Other Identifier:
***P2. .Location: *a. County** Solano
b. Address: 120-122 East J Street
***c. City:** Benicia **Zip** 94510
d. UTM: N/A
e. USGS Quad: Benicia T2N R3W MDM
***f. Other Locational Data (APN #):** 89-051-16
***P3a. Description**

BUILDING, STRUCTURE, AND OBJECT RECORD

B2. Common Name: St Paul's Guild Hall

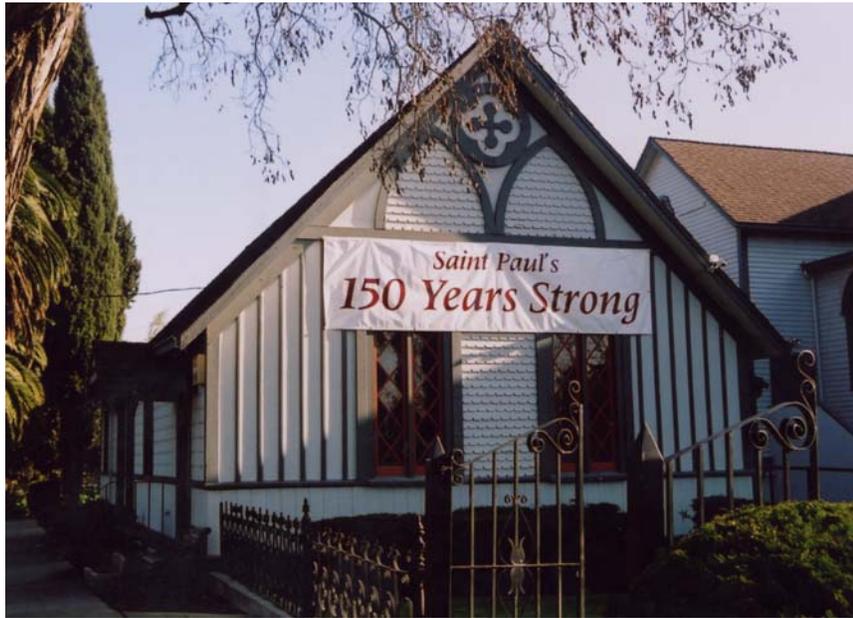
This is a Gothic Revival Building with a steeply pitched gable roof and a rectangular plan. The gable end of the building is oriented toward J Street and is the most elaborate part of the building. The front or entry of the building is oriented toward East J Street and is relatively plain in appearance. The steep side gable is finished with a plain fascia and verge board. The gable end is decoratively treated with an applied wooden rosette that has a stylized crucifix in the center. Two applied wooden Gothic arch forms are applied below the rosette and are decoratively shingled. The gable end is closed. The wall is clad with board and batten except in the central portion between the symmetrically arranged windows where it is shingled in the same pattern as the applied arches in the gable. The lower wall is wide tongue and groove. Two Gothic casement windows are found on the west wall. They are vertically emphasized with diamond pattern glazing. The front of the building is clad with a combination of clapboard and tongue and groove. A small gable roof porch covers the entrance. It is supported on plain wooden posts and may have been added later.

Front façade, view east
***P6. Date Constructed/Age:** Circa 1886
 Prehistoric Historic Both
***P7. Owner and Address:**
 St Paul's Parish
 122 East J Street
 Benicia, CA 945510
***P8. Recorded by:**
 Carol Roland
 Roland-Nawi Associates
 4829 Crestwood Way
 Sacramento, CA 95822
***P9. Date Recorded:** 11-20-04
***P10. Type of Survey:** Intensive
 Reconnaissance Other
Describe Eligibility Evaluation
***P11. Report Citation:** none
***Attachments:** NONE Map Sheet Continuation Sheet Building, Structure, and Object Record Linear Resource Record Archaeological Record District Record Milling Station Record Rock Art Record Artifact Record Photograph Record Other (List):
