PRIMARY RECORD

*Resource Name or #: St. Paul's Episcopal Church Rectory

- P1. Other Identifier:**
***P2. .Location: *a. County** Solano
b. Address: 120-122 East J Street
***c. City:** Benicia **Zip** 94510
d. UTM: N/A
e. USGS Quad: Benicia T2N R3W MDM
***f. Other Locational Data (APN #):** 89-051-16

BUILDING, STRUCTURE, AND OBJECT RECORD

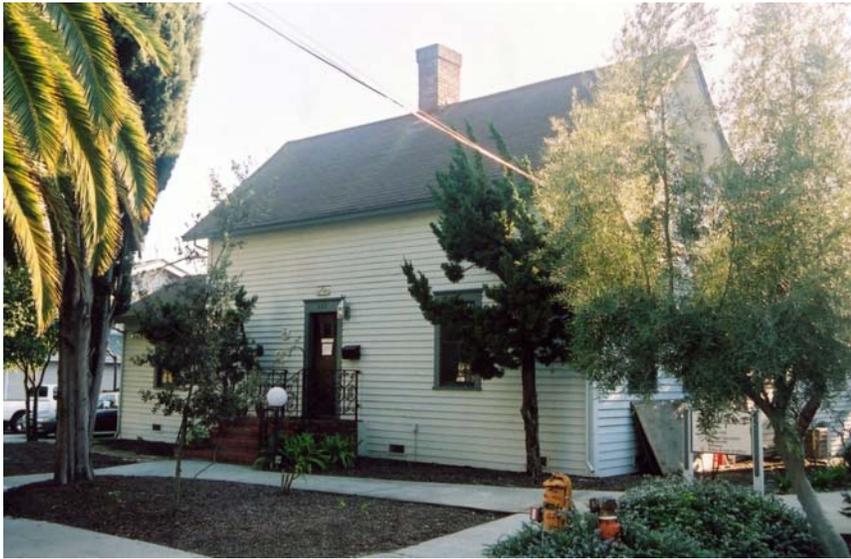
P5. Photograph or Drawing (Photograph required for buildings, structures, and objects.)

The Rectory is believed to have been transported in 1868 by Col Julian McAllister from Torrington, Connecticut, to serve as the parish house for the Church of St Paul. This information, though widely accepted is not well documented. The house is a one and one-half story residence of the central chimney Hall and Parlor type, a Vernacular form widely used in the New England area. The building has a shed roof rear addition which forms a "salt box." The building has a steep side gable roof. It has small eave and gable overhangs. It has only one window opening on the front façade on the west side. Other fenestration is found on the gable ends and is symmetrically arranged. The entry to the building is located on the north side of the building and has a simple pediment above the door. The building is clad in lap siding. The building is one of the oldest in Benicia.

Front façade, view southeast
