# PRIMARY RECORD

\*Resource Name or #: 130 West G Street

b. Address 130 West G Street

## BUILDING, STRUCTURE, AND OBJECT RECORD

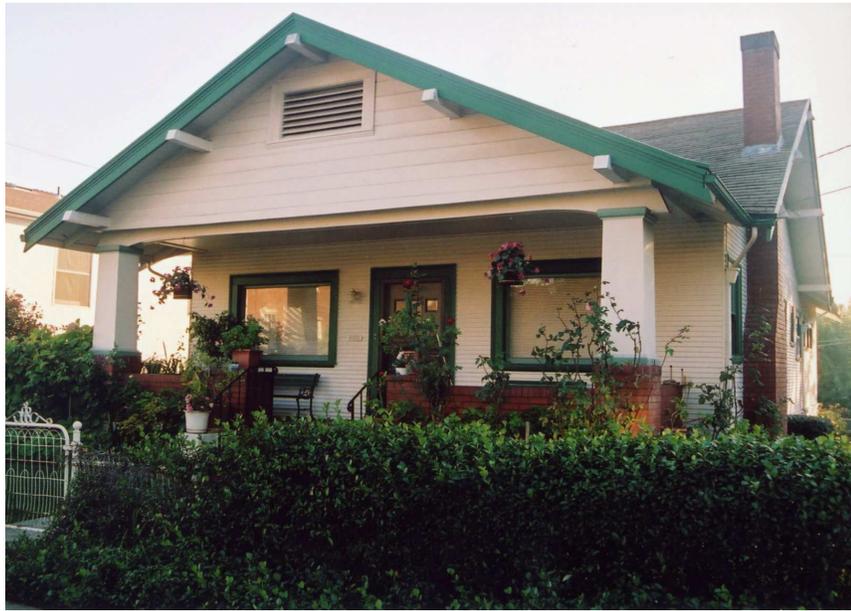
P5. Photograph or Drawing (Photograph required for buildings, structures, and objects.)

This Bungalow style house has a cross gable roof of moderate pitch with wide overhangs and exposed rafters and purlins. A prominent front gable extends to cover the full-length front porch which is supported on battered posts. A closed brick rail encloses the porch which is accessed via concrete steps. The entry and fenestration are symmetrically arranged on the front façade. Front windows are fixed, while other windows are double hung with one-over-one sash. The solid entry door exhibits a decorative glazing pattern in the upper half. The house is clad with novelty siding.

Front façade, view south
