# PRIMARY RECORD

- \*Resource Name or #: 133 East G Street  
P1. Other Identifier: none  
\*P2. .Location: \*a. County Solano  
b. Address 133 East G Street  
\*c. City: Benicia Zip 94510  
d. UTM: N/A  
e. USGS Quad: Benicia T2N R3W MDM  
\*f. Other Locational Data (APN #): 89-341-18  
\*P3a. Description:

## BUILDING, STRUCTURE, AND OBJECT RECORD

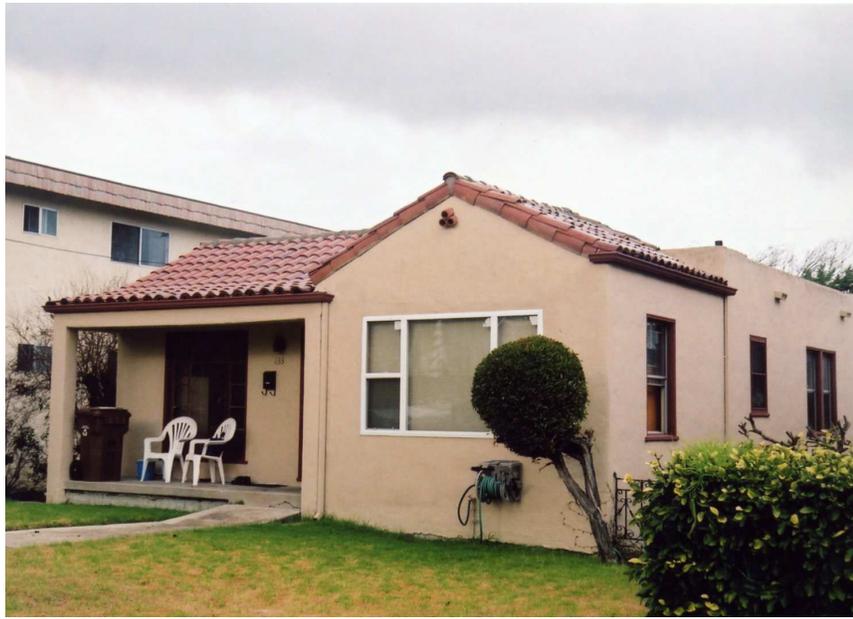
P5. Photograph or Drawing (Photograph required for buildings, structures, and objects.)

This is small single story Mediterranean Revival house. The residence is L-shape in plan with a cross gable roof. The roof is Mission tile. The gable end is finished with a decorative row of Mission tile and has a ceramic tile pipe attic vent. A covered porch is cut into the west side of the façade. The porch roof is supported on stuccoed posts. A horizontally emphasized fixed central window with double hung sidelights occupies the projecting gable wall, while a long casement window is found on the west side of the front façade. Other fenestration is double hung. Cladding is stucco. The house is sited on an incline and is two-story at the rear along the alley.

- \*P3b. Resource Attributes: HP2  
\*P4. Resources Present:  Building  Structure  Object  Site  District  Element of District  
P5b. Description of Photo:  
Front façade, view north  
\*P6. Date Constructed/Age: 1930  
 Prehistoric  Historic  Both  
\*P7. Owner and Address:  
Dickie & Gail Hill

The house is a good example of a simple Mediterranean Revival Style residence from the period of the 1930s. It does not appear to have undergone any major alterations and retains its integrity of design, materials, workmanship, setting, location and association. It is typical of infill housing that was constructed in the downtown area in the 1920s and 1930s. The early 20<sup>th</sup> century was a period of limited economic growth in the town with only a small number of modest residences added to the housing stock. The house currently is a contributor to the Downtown Historic District and should retain this status.
