PRIMARY RECORD

*Resource Name or #: 141 East H Street

b. Address: 141 East H Street

BUILDING, STRUCTURE, AND OBJECT RECORD

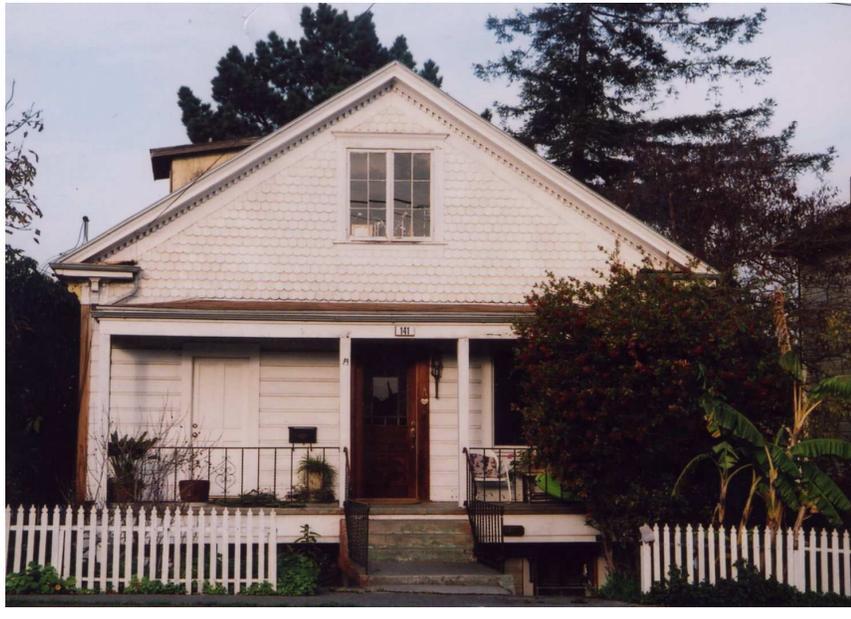
P5. Photograph or Drawing (Photograph required for buildings, structures, and objects.)

This rectangular plan building combines elements of Greek Revival Style with Victorian period decorative elements. The roof treatment with a molded fascia and a cornice with dentils and eave returns are consistent with the Greek Revival. The wide gable end has a centrally placed paired window with a pediment at the top of the casing. A full-length porch with a shed roof extends across the front facade and is supported on plain posts. A centrally placed paneled and glazed door provides primary entry, but there also is a secondary door, located on the west side of the façade. Fenestration is mixed with both original and new windows. On the front façade the east window has been replaced with plate glass and it is possible that the west entry door was created by the removal of a window in that location. A modern shed roof dormer has been added to the west roof slope. The house is clad in clapboard while the gable end is finished with fish scale shingles.

Front façade, view north
