State of California — The Resources Agency
 DEPARTMENT OF PARKS AND RECREATION
PRIMARY RECORD

*Resource Name or #: 433- 439 First Street

BUILDING, STRUCTURE, AND OBJECT RECORD

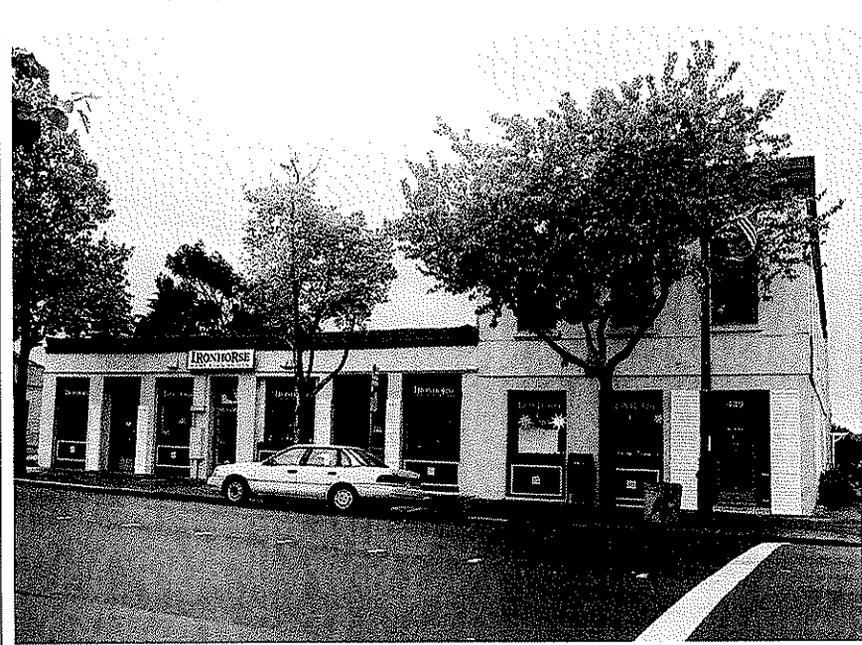
P5. Photograph or Drawing (Photograph required for buildings, structures, and objects.)

This property consists of a two-story wing on the north side of the building and a single story wing on the south. The building has a rectangular footprint. Both wings have flat roofs with a dentil cornice. The first story consists of three commercial/shop spaces. The shop in the two-story wing has an entrance at the north corner of the building. There are two store windows to south. In the one story wing central shop doors with transoms are flanked by storefront windows on either side. Fenestration on the second story of the building consist of one-over-one double hung windows. The building is clad in stucco with decorative ceramic tile inset under the store front windows.

P5b. Description of Photo:

Front façade, view southwest
