PRIMARY RECORD

*Resource Name or #: 440 First Street

BUILDING, STRUCTURE, AND OBJECT RECORD

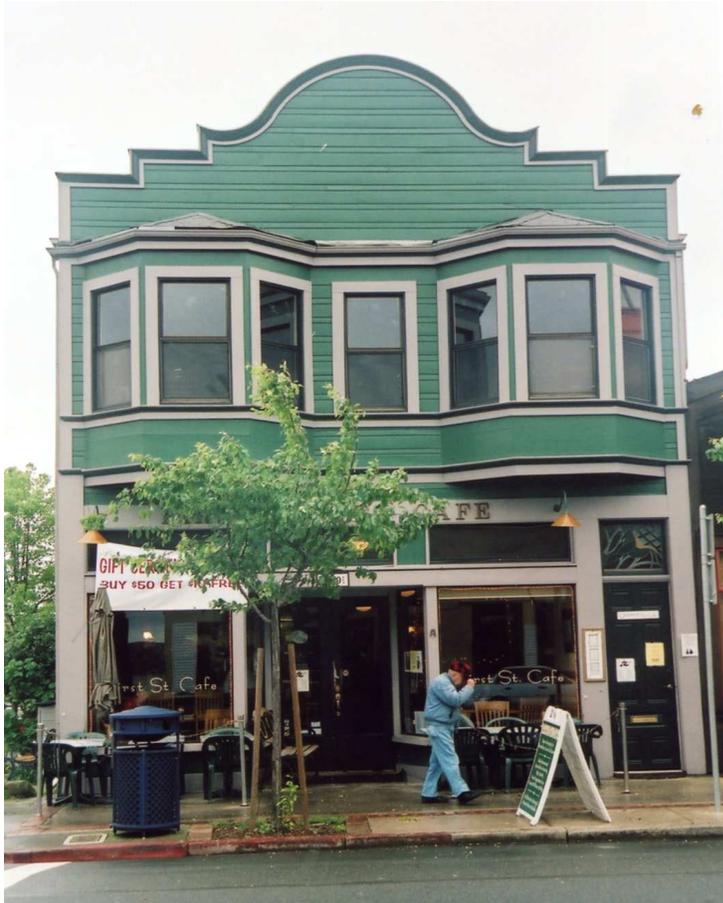
P5. Photograph or Drawing (Photograph required for buildings, structures, and objects.)

This is a typical 19th century commercial building with a storefront on the lower story and a residence or offices above. The building is rectangular in plan with a false front that consists of a stepped and semi-circular pediment. There are two entries located on the front façade. The principal business entry is recessed and centered between the canted storefront windows and has a double glazed door. The second entrance is located on the south side of the façade and is a single glazed door with a transom. Lower story fenestration is limited to the two storefront windows which have a clerestory above the windows and the entry. On the second story fenestration consists of two symmetrically arranged canted bays with hip roofs. These are similar to the canted upper bays on the Jorgensen building and belong to a 19th-century commercial building form frequently found in the Bay Area. There is a single window centered between the two bays over the entry. Windows on the side elevations are symmetrically arranged. All windows are one-over-one double hung. The building is clad with clapboard.

Front façade, view east
