PRIMARY RECORD

*Resource Name or #: Jurgensen's Saloon

- P1. Other Identifier:** Lido's
- *P2. .Location: *a. County Solano
- b. Address: 501 First Street Formerly 100 First Street
- *c. City: Benicia Zip 94510
- d. UTM: N/A
- e. USGS Quad: Benicia T2N R3W MDM
- *f. Other Locational Data (APN #): 89-173-18

BUILDING, STRUCTURE, AND OBJECT RECORD

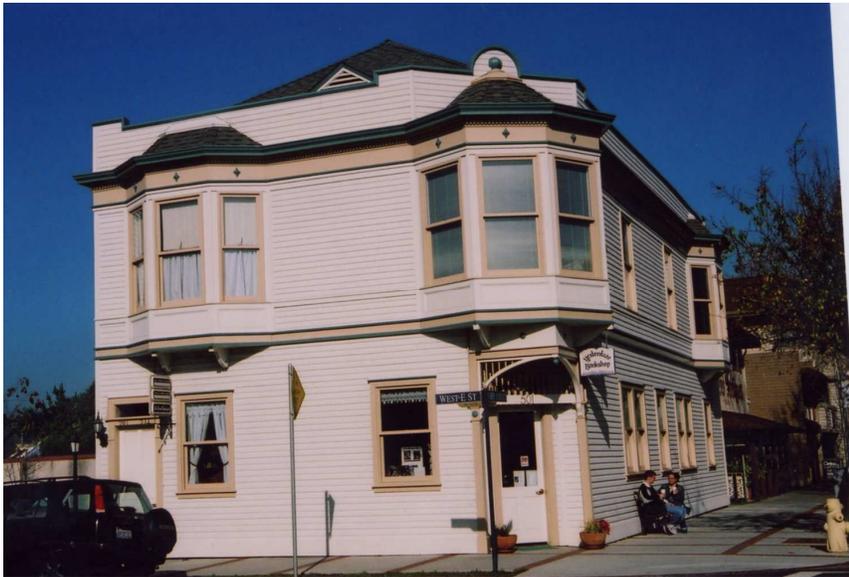
P5. Photograph or Drawing (Photograph required for buildings, structures, and objects.)

This is a two-story Queen Anne commercial building. The building has a hip roof with a stepped parapet with a decorative half arch motif at the corner of the. Just below the parapet octagonal roofs cover the multiple projecting upper story bays. At the level of the bay roofs a fascia and decorative cornice provide visual linkage along the roof line. Rectangular in plan, the lower story has a plainer surface broken by a corner entry. The entry is cut into the front corner of the building with the upper story corner overhang creating an entry cover. The entry is embellished with decorative spindle work supported on pilasters. The door is recessed. A door to the second-story is found on the west end of the south façade. Lower floor fenestration consists of single and paired one-over-one windows with wooden casements. The second story has an overhang which is emphasized by a beltcourse. Canted bays are located on each of the side elevations and over the corner of the building. Additional upper fenestration consists of one-over-one double hung windows. The form of the building is one that is common in San Francisco and the Bay area with commercial space on the first floor and offices or residential space above. The multiple canted upper bays are a noteworthy feature of these building. This appears to be the only building of this type to have survived in Benicia.

Front façade, view northwest
