PRIMARY RECORD

*Resource Name or #: 717 West Second Street

717 West Second St
Benicia, CA 94510

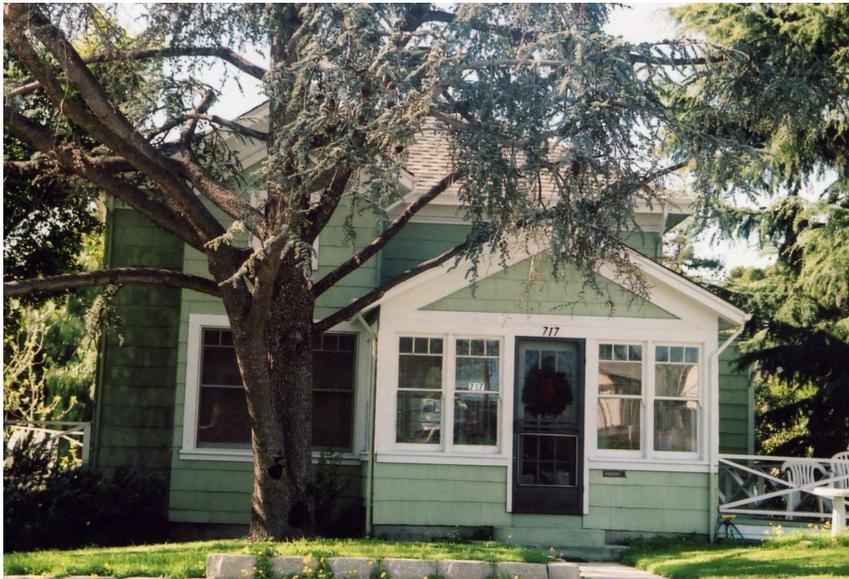
P5. Photograph or Drawing (Photograph required for buildings, structures, and objects.)

This appears to have originally been a two-story Italianate house which has been substantially modified. The house has a hip roof of moderate pitch with overhanging closed eaves and a plain cornice. The south side of the front façade is occupied by a projecting gable roofed two-story square bay, while the north side of the façade is occupied by a one-story gable roof vestibule. Both gable ends have overhangs with wide verge boards. Fenestration consists of double hung windows with decorative upper panes. Casings and sills are wood. The entry door is multi-light with a small concrete stoop. The cladding is asbestos shingle.

Front façade, view west

This house is an odd combination of elements from different periods. The primary mass of the house and the two-story square bay on the south side of the front façade indicate that the house was originally constructed in the Italianate Style. The treatment of the eaves and cornice further support this probability. The form of this part of the house is very similar to other Italianates in Benicia. However, the front vestibule appears to date from the 1920s and is Craftsman in massing, form, roof treatment and arrangement of fenestration, although the windows themselves may date from the original construction. The horizontality of the vestibule contrasts markedly with the verticality of the main house core. Additionally the original cladding has been replaced with asbestos shingle. The house lacks integrity in design and materials and to a large degree, workmanship. It retains its authenticity of setting and location. The house currently contributes to the local district, but should be reconsidered in as much as it does not meet either a state or federal integrity standard.
