PRIMARY RECORD

*Resource Name or #: 800 First Street

b. Address: 800 First Street

*c. City: Benicia Zip 94510

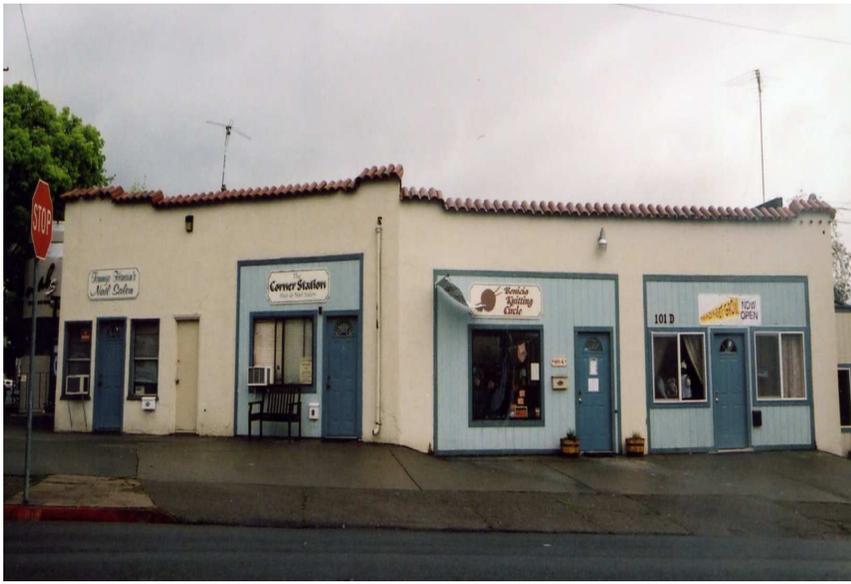
P5b. Description of Photo:

This building was originally constructed as a gas station in the 1920s or early 1930s. It is Mediterranean Revival in style, a common stylistic choice for this new type of structure in the 1920s. The building curves around the corner site and consists of four bays. It is one-story with a flat roof and a stepped pediment with Mission tile trim. The office at the northwest end of the building has a central entry door flanked by one-over-one double hung windows. There are three service bays that originally had double wide garage openings. These have now been closed with vertical board siding and converted to shops.

Front façade, view north
