PRIMARY RECORD

*Resource Name or 900 East Second Street

b. Address: 900 East 2nd Street

BUILDING, STRUCTURE, AND OBJECT RECORD

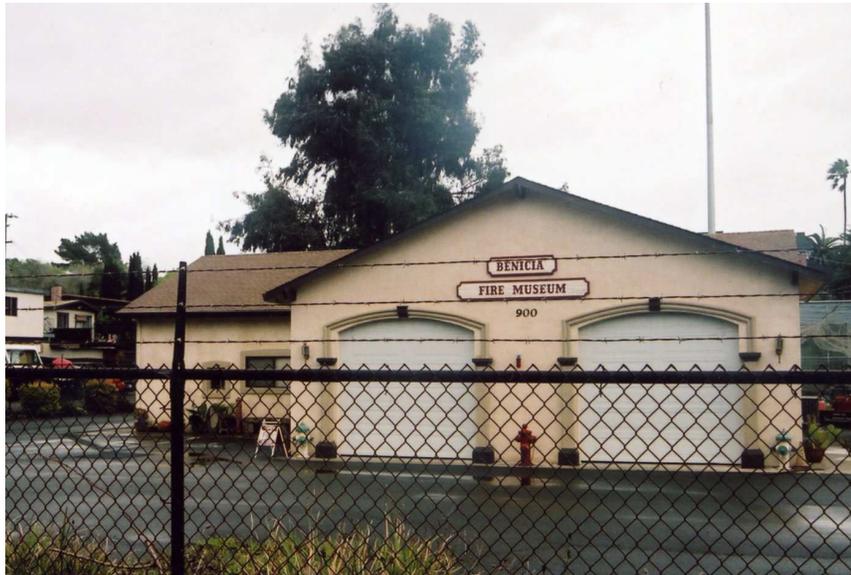
P5. Photograph or Drawing (Photograph required for buildings, structures, and objects.)

*P3a. **Description** The fire museum is a circa 1930 Mediterranean Revival fire station. L-shape in plan, it has a moderately sloped cross gable roof with small gable overhangs trimmed with a plain fascia. The most distinguishing feature of the building is its double garage door openings located on the front gable end wall. The wide garage door openings are flanked by pilasters with a square capital and a molded upper casing. The doors are set back from the façade and are framed by these elaborated elements. The rest of the building is utilitarian. Cladding is stucco.

Front façade, view east
