PRIMARY RECORD

*Resource Name or #: 901 First Street

b. Address: 901 First Street

BUILDING, STRUCTURE, AND OBJECT RECORD

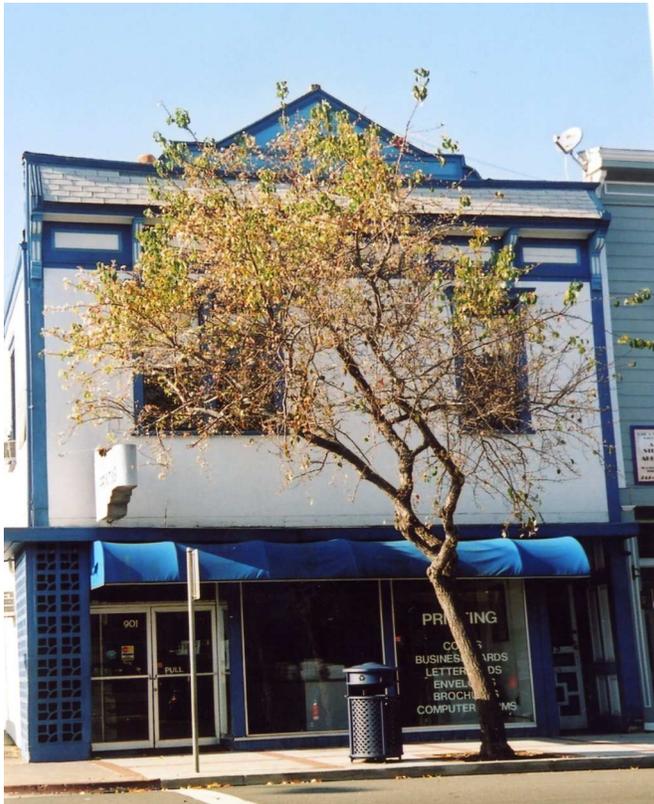
P5b. Description of Photo:

This is an Italianate commercial building from the late 19th century. With slight variation in detail its design is almost exactly like that of the commercial building across the street at 828 First Street. It is two-story and has a false front with a gabled pediment. The pediment has an overhang supported on brackets with an elaborate cornice. Front upper story front fenestration consists of a single and a paired set of two-over-two double hung windows with pediments supported on brackets. Other upper story fenestration consists of two-over-two double hung windows without pediments. The lower story storefront has been extensively modified with the typical central entrance flanked by storefront windows was removed and replaced with a floor to ceiling plate glass "wall" and double metal and glass doors. A cinder block corner piece has been used to "modernize" the lower story at the south corner. The building, which was probably originally clapboard has been reclad with stucco.

Front façade, view west

This building is a contributor to the Downtown Historic District. However, it has seriously compromised integrity for a building of this status. The entire lower store front has been replaced, probably circa 1950, with plate glass and metal frame doors. This substantially alters the appearance of the building at the street level, although the upper story continues to convey the 19th century origins of the building. Integrity has further been damaged by the application of stucco over the original siding. The changes to the building are of a sufficient magnitude to have a serious impact on its integrity. With these alterations the building generally would not be eligible for listing in the California Register of Historic Resources. However, because of the continuity of the commercial block it should retain its contributing status. Changes to the building other than those that would rehabilitate it to a more historic appearance would remove it from contributing status.
